III. STRUCTURAL STABILITY AND EARTHQUAKE VULNERABILITY

Location of Nemrut Dag with Emphasis on Seismic Issues

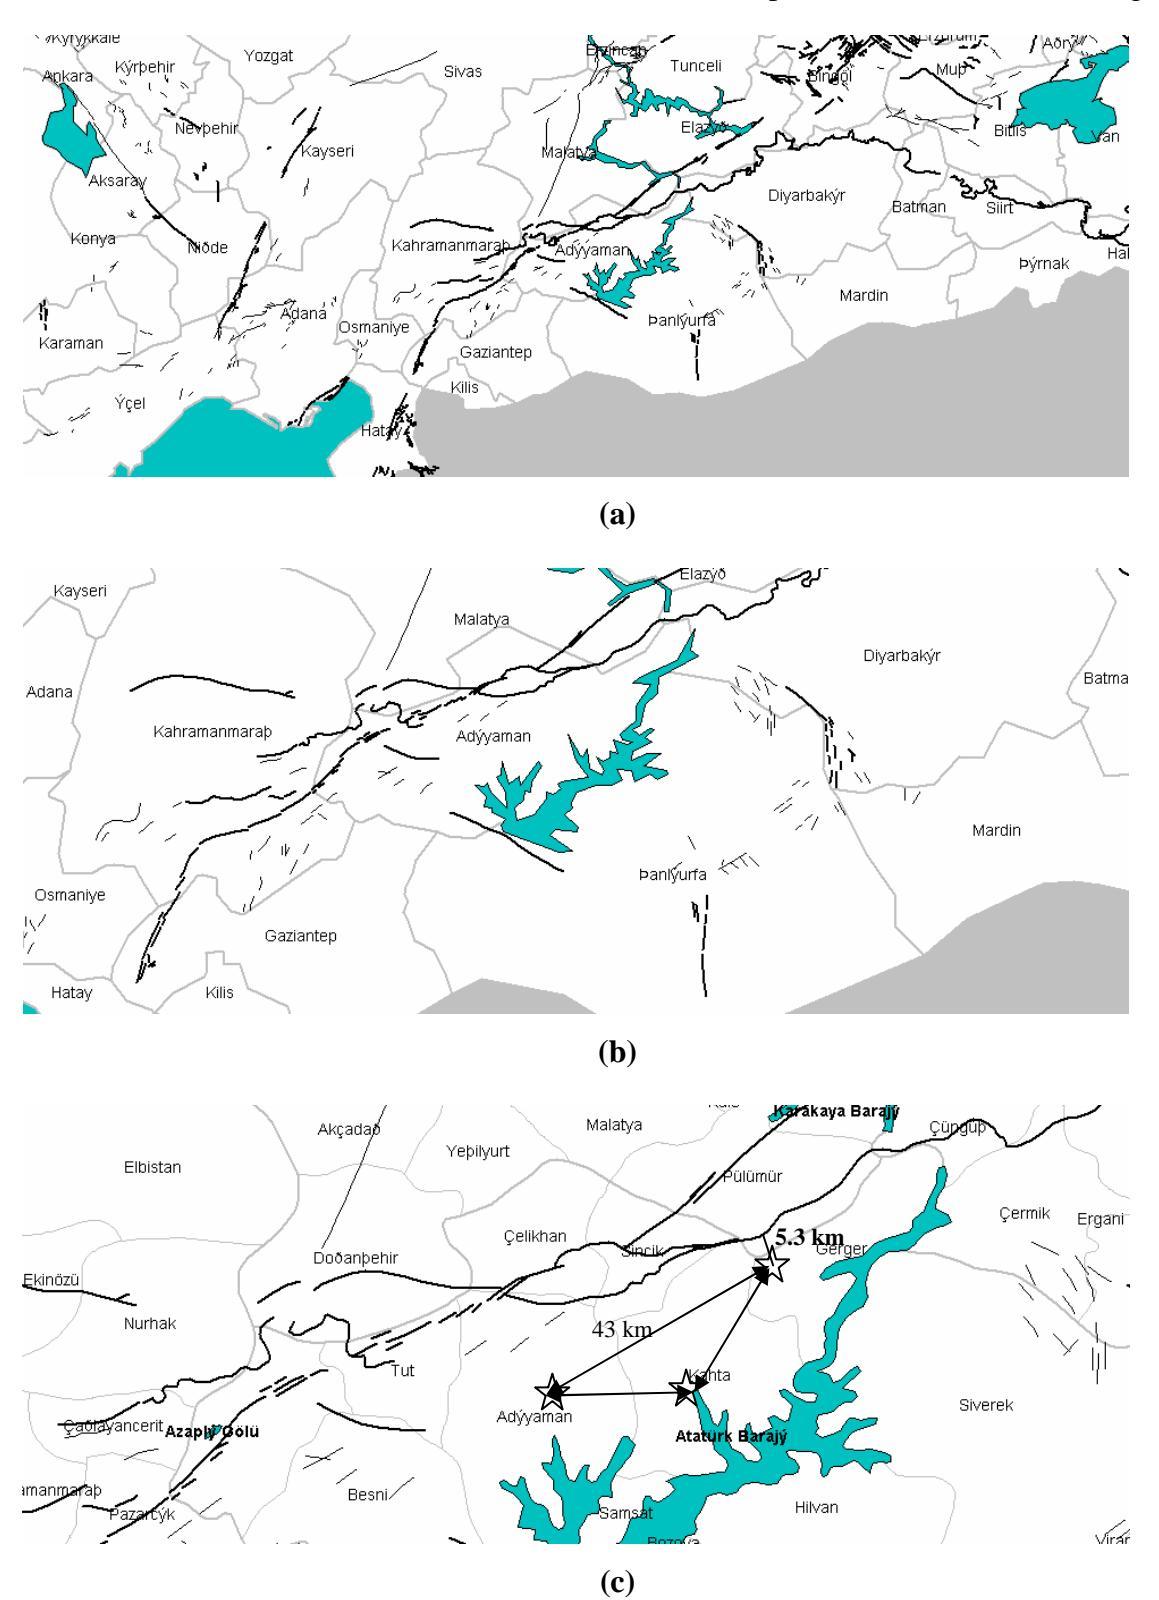
Figure 4 Location of Nemrut on Major Active Faults Map of Turkey (zoomed)

In addition to the horizontal forces generated during a possible earthquake, there will be "near field effects" associated with the closeness of the Nemrut site to the active fault. Nemrut is located 5 to 12 kilometers away from the fault line (see Figure 4). When a site is located too close to a fault line, the permanent displacement and vertical accelerations combined with the horizontal accelerations generate even a worse condition on existing structures. The pieces of stone blocks piled on top of each other (without shear keys) are extremely vulnerable to earthquakes. Reerection of monuments should definitely be prohibited without making any detailed analysis and tests on scaled lab models.

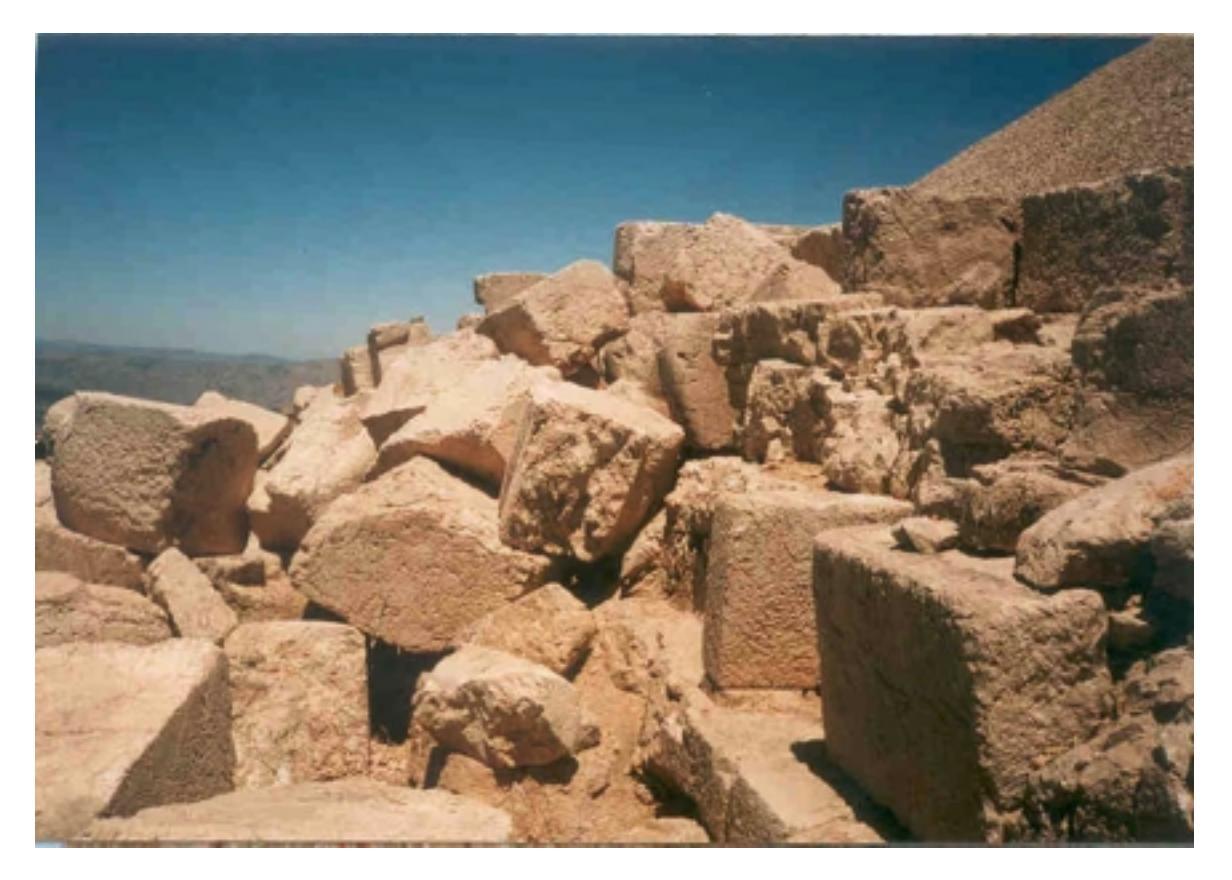
The stone blocks of the west side are all dislocated and resemble rubble (Figure 8). The east side monuments suffer serious dislocation although the larger monuments still stand up excluding the heads. The eagle and lion statues are down at both sides of the mountain. The standing portions on the east side have serious structural conditions that must be addressed as an emergency:

Figure 8 Totally Collapsed Statues at the West Side

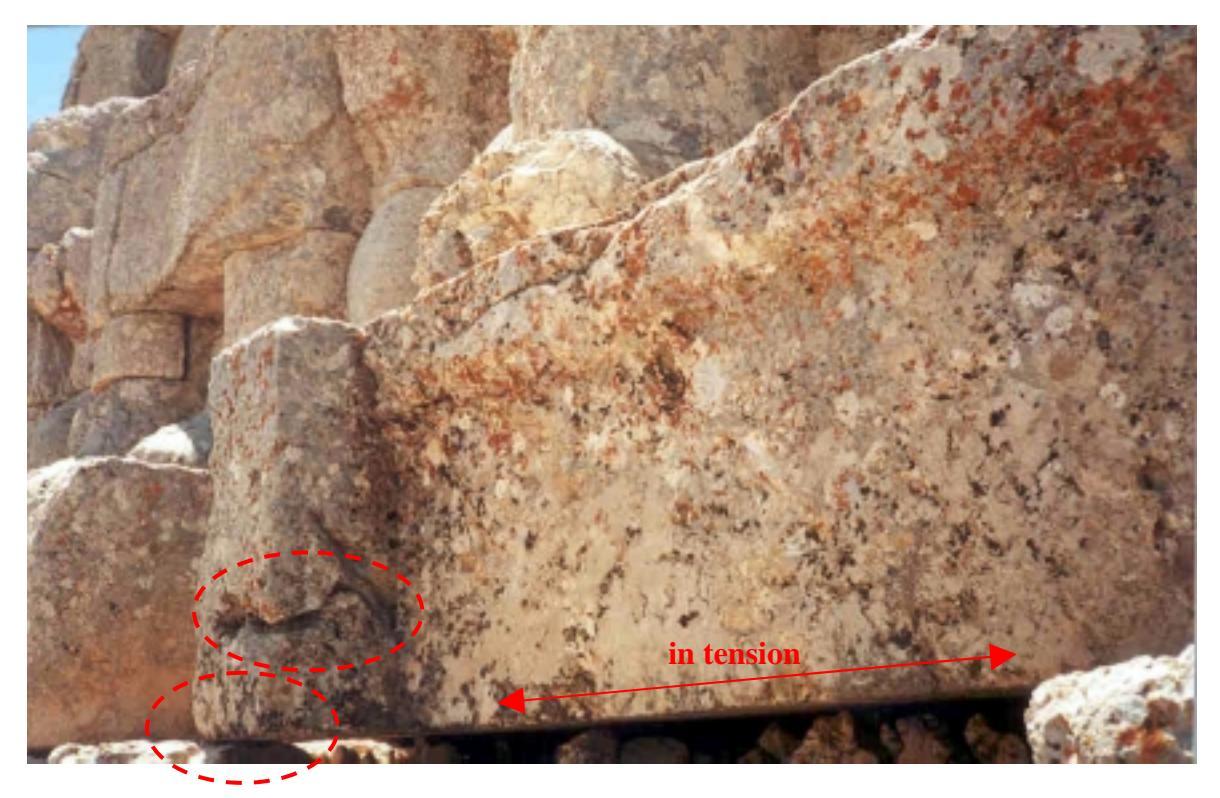
- Base stone of Herakies, the one next to the eagle, has a base stone with a critical cavity underneath (Figure 9). The base stone is carrying a large load in flexure, simply supported at both ends and might possibly let the whole massive weight go soon with the initiation of the first crack. Although the void underneath the stone is in the range of about 10cm, a failure in the base stone tension zone would lead to instability of the remaining stones.

Figure 9 Base Stone of Herakies, Simply Supported and Fracture Critical (East)

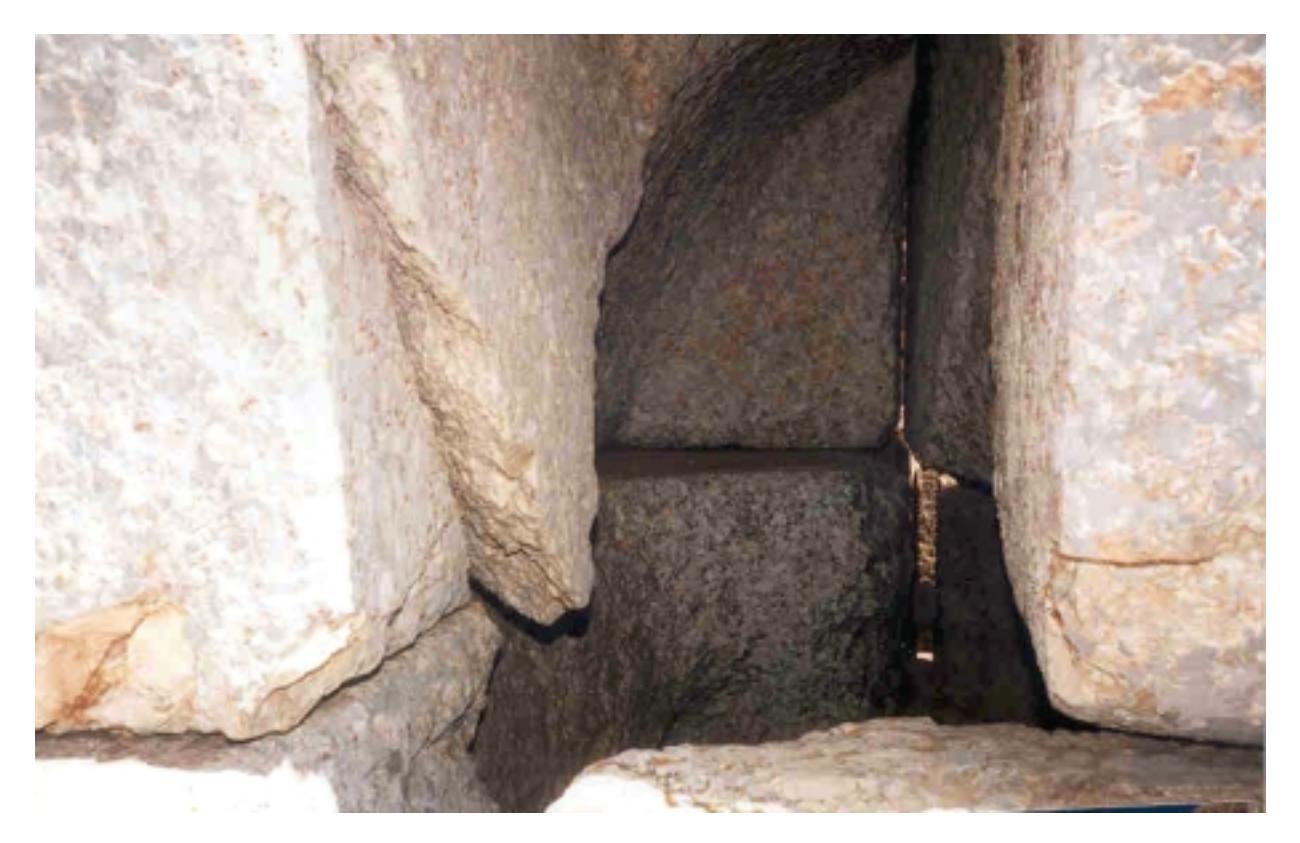
- Herakies again has a seriously fractured stone block, as shown in Figure 10, which may lead to structural failure. The stabilization of the fractured blocks should be addressed immediately.

Figure 10 Fractured Upper Block of Herakies, May Lead to Sudden Failure

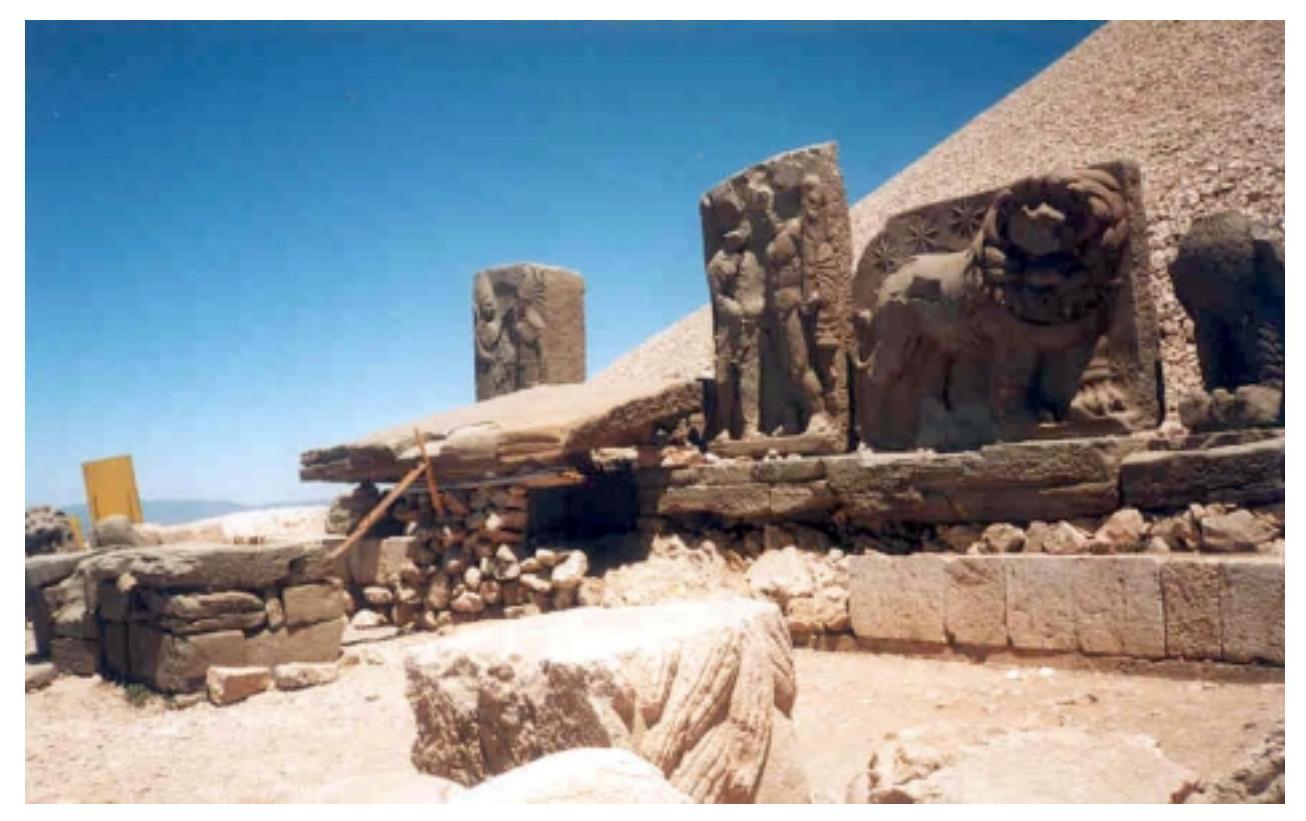
- The second Stelae from the left was tipped and fell face wards during snowy season (Figure 11). (Before damage condition can be seen from the local postcards Figure 12). The current condition of the stone is very unstable and in a dangerous condition for itself and for the visitors. The Stelae must be urgently stabilized.

Figure 11 Tipped Stelae on West Side

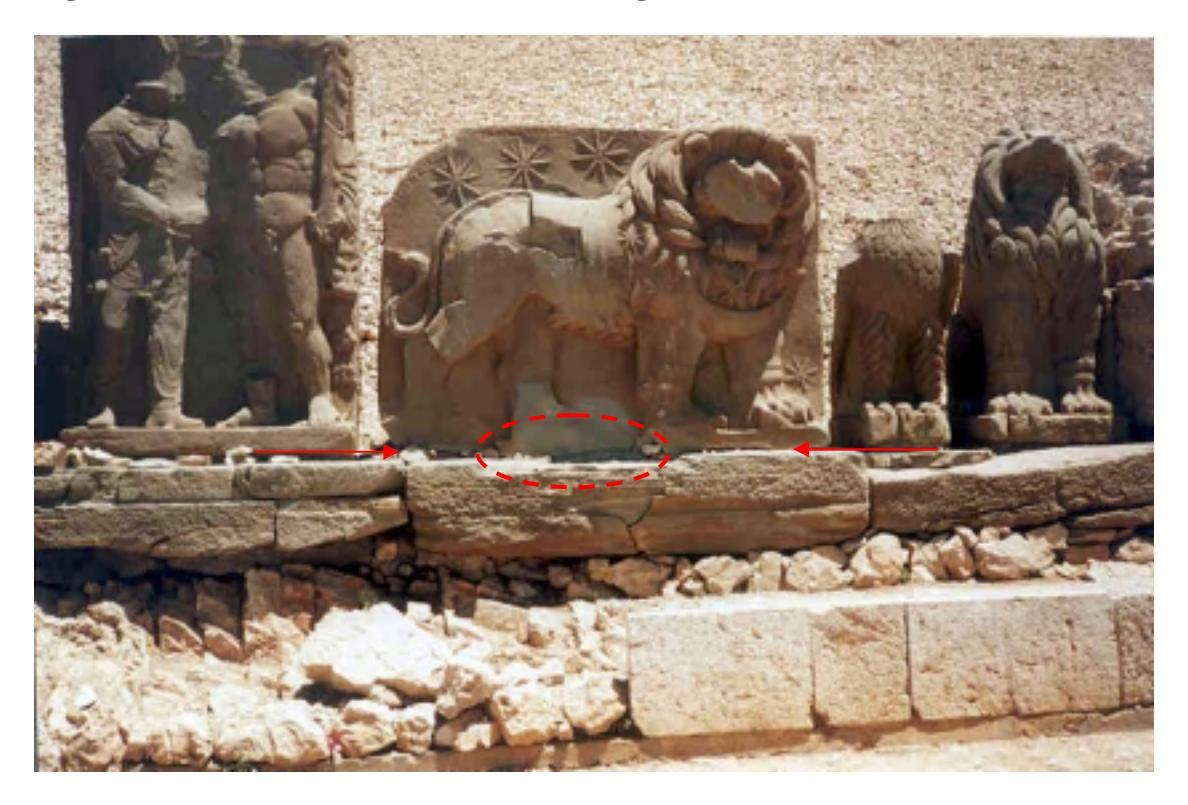
- Other (still standing) Stelaes are poorly designed for lateral forces. The contact areas at the base are very small. Concrete mortar was used in a previous attempt to fix the base of the Lion Stelae (see Figure 13). Only about ¼ of the base is keeping the Stelae up and all Stelaes are very vulnerable to earthquake forces. Even the snow pressure from behind (the mountain side) is enough to tip the Stelae (Figure 11). Combined with degrading and deteriorating stone structure of Stelaes (due to freezing and thawing) it may be recommended to place them on the ground with full base contact to prevent any bending moment formation. They may be preserved in plastic airtight wraps during off-season and from precipitation.

Figure 13 Poor Base Design of Stelaes (West Side)

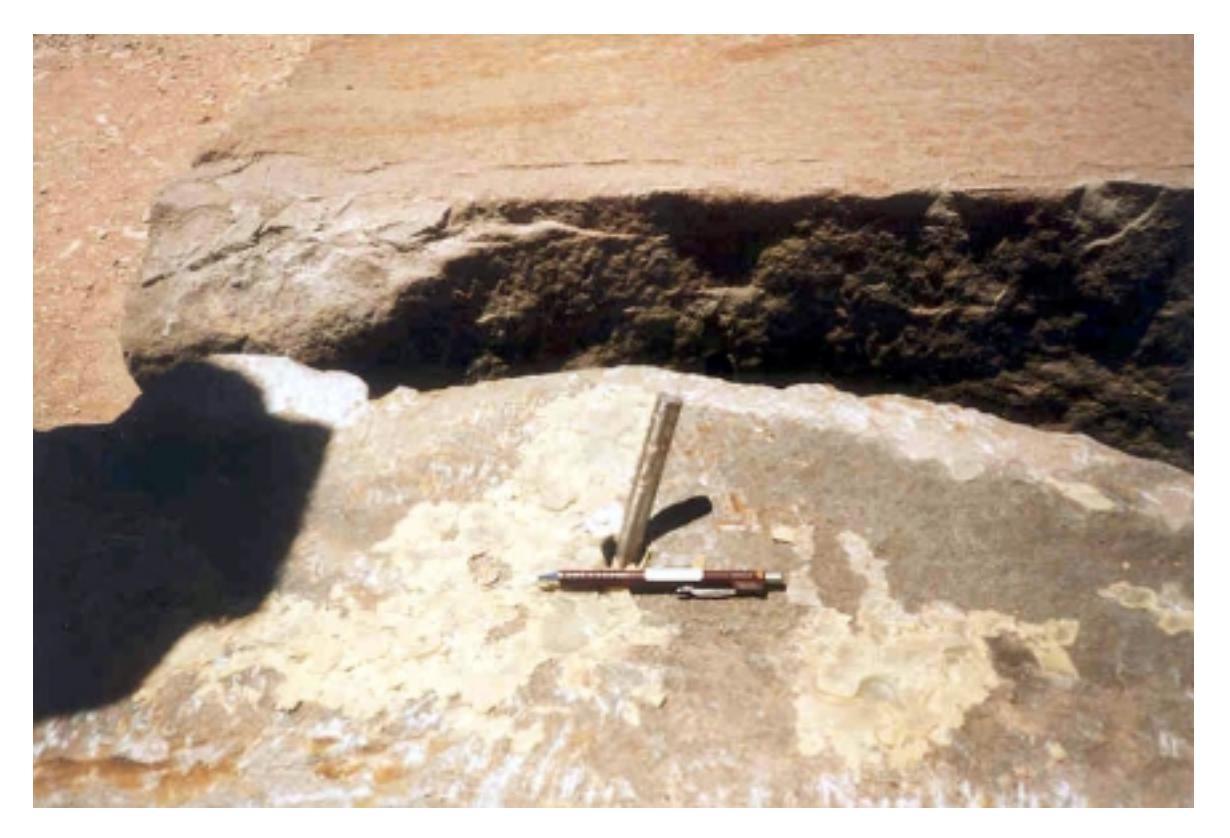
Stabilization studies conducted in 1980's on the Lion Stelae at west side were very badly designed and actually ended up damaging the Stelae even more. The steel rods placed inside the two facing stone pieces were very short compared to 'development length' to fully make use of the steel rods (Figure 14). Therefore, the rods slipped out of the drill holes without resisting overturning. The epoxy used had no use holding the pieces together. The two rods placed at the cross section were of different diameters and different material properties (rusting and stainless steel) as it can be seen in Figure 15. The rods were located close to the center of the stone cross section where the neutral axis is expected to exist. Over a cracked section, the rods would have better be placed close to the edges of the section for improved overturning resistance. <u>Careful planning and investigation should be conducted at the Nemrut Site to prevent further similar mistakes and losses.</u>

Figure 14 Very Short Rod Length Incapable of Generating Axial Force

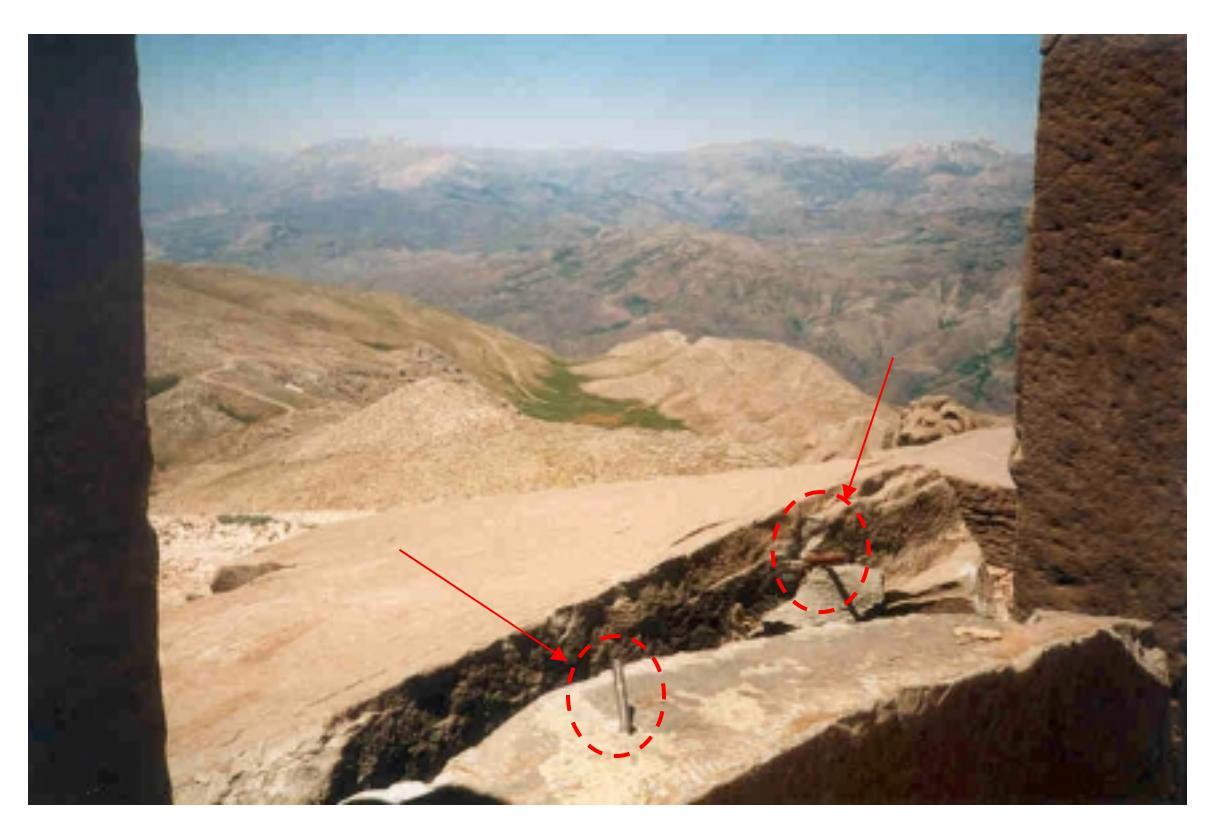
Figure 15 Different Diameter and Materials (Stainless-Rusting) Used for Re-bars
