## The Nemrud Dağ Project

Proposal for the 2005 campaign

Application for work permit : Campaign 1 June - 10 August 2005

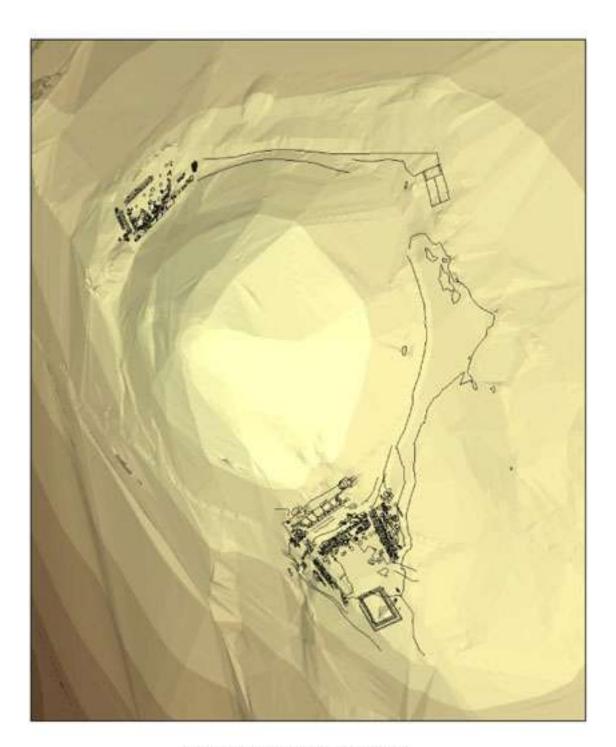
Fig. 2 3D impression of the Nemrud Dag.

Fig. 2. 3D impression of the Nemrud Dag.

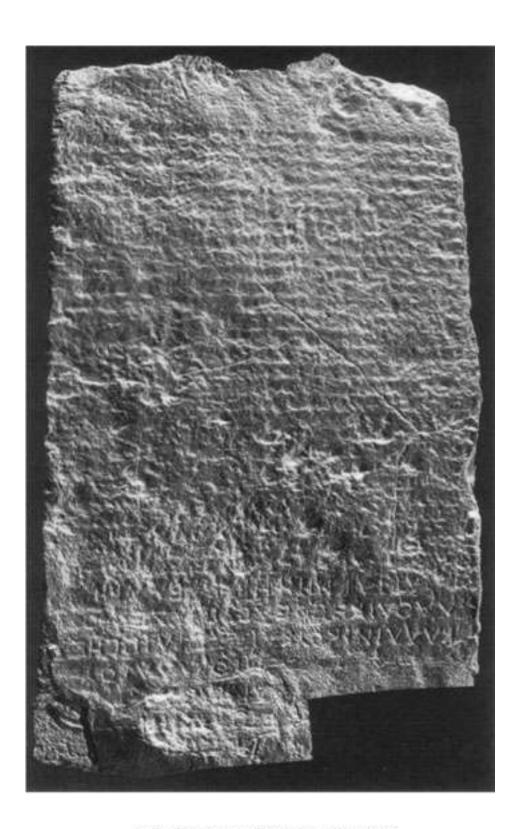
Fig. 7. Paper squeeze of inscription, made in 2002.

e. PHOTOGRAPHICAL DOCUMENTION of the inscriptions still present on the Nemrud Dağ, with a few exceptions. Special attention was paid to the 'palimpsest' inscriptions at the backs of the stelae on the West Terrace; these inscriptions have been chiselled over already in antiquity. Paper squeezes of the inscriptions (Fig. 7) were taken and scans were made using a Minolta High Definition non-contact 3D scanner.

Fig. 7. Paper squeeze of inscription, made in 2002.

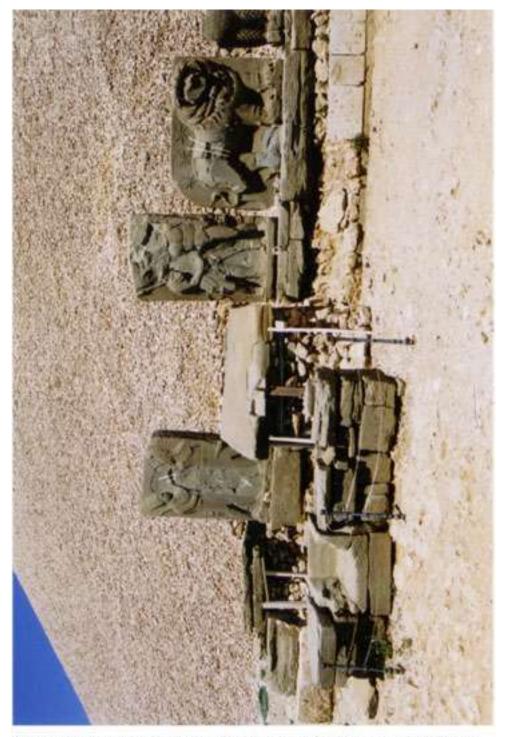
Fig. 15. Two sandstone devices stelae (first and third ones on the left of the row of five) in the north-eastern section of the West Terrace have fallen forward down during the winter of 2001-2002: those of Antiochos-Kommagene and Antiochos-Zeus (Fig. 15). Supports of stone blocks were made. The stelae of Antiochos-Apollo, Antiochos-Herakles and the lion horoscope were treated provisionally and reinforced. Situation in August 2002.

a. Due to the pressure force of the mass of snow sliding down during the winter period of 2001-2002, two sandstone stelae of the row of five in the north-eastern section of the West Terrace have fallen forward down: the Antiochos-Kommage dexiosis stele and that of Antiochos-Zeus dexiosis. The other two dexiosis stelae – of Antiochos-Apollo and Antiochos-Herakles – and the lion horoscope relief remained standing upright. The latter three reliefs were treated provisionally and have been consolidated with tapes of so-called Japanese rice paper (Fig. 15). A snow barrage was constructed in order to prevent the three standing stelae from falling down during the following winter period (Fig. 16). In June 2003, first the snow barrage was disassembled. It has prevented the three still standing sandstone stelae from falling down.

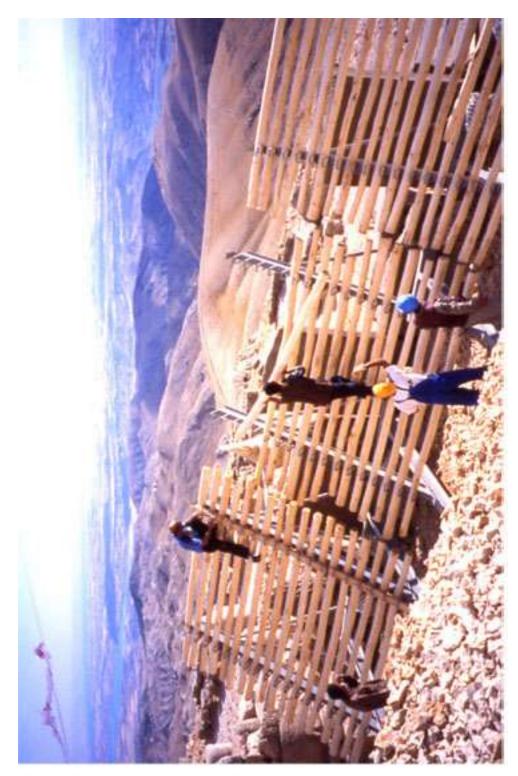
Fig. 16. The snow barrage at the back of the row of sandstone stelae in the north-eastern section of the West Terrace. It was constructed in July/August 2002 in order to prevent the three standing stelae from falling down during the next winter.

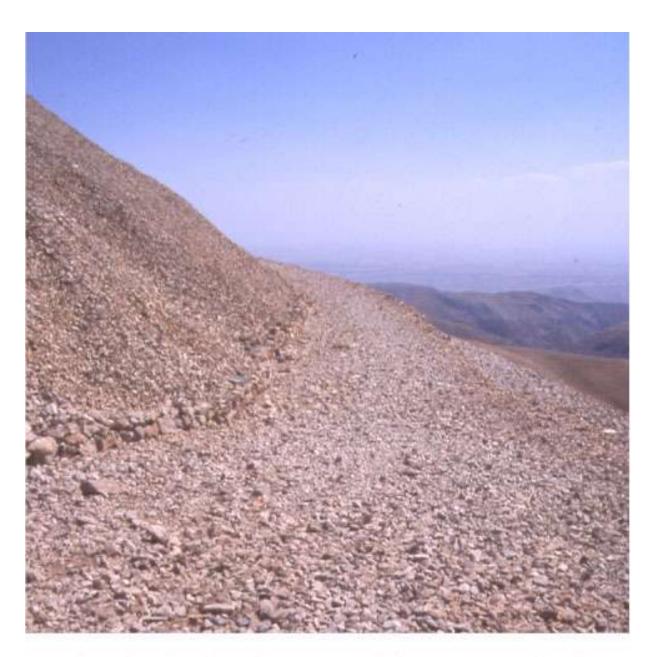
Fig. 18. The pathway between the West Terrace and the temporary conservation and restoration laboratory. It was raised, reinforced and levelled in July 2003.

c. The pathway between the West Terrace and the temporary conservation and restoration laboratory was raised with gravel consisting of small pieces of local limestone, reinforced and levelled. This was necessary because of the transport of the five stelae by crane from their plinth in the north-eastern section of the West Terrace to the laboratory. The results are shown in Fig. 18. This extended pathway facilitates the visit of tourists and the work of the restorers and researchers in future.

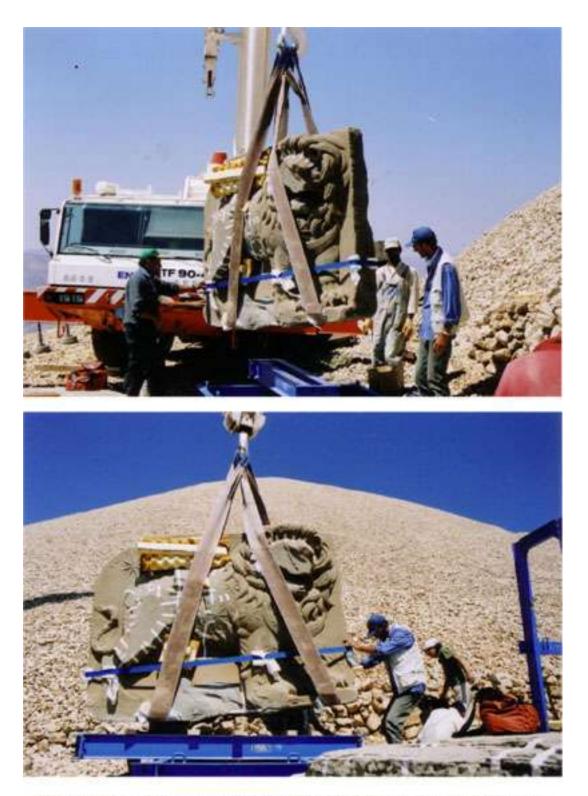
Fig. 19. Transportation by crane of the sandstone stelae from their plinth in the north-eastern section of the West Terrace to the conservation and restoration laboratory.

d. All five sandstone stelae in the north-eastern section of the West Terrace were reinforced with so-called Japanese rice paper and prepared for transportation to the newly built conservation and restoration laboratory. Each stele was framed by steel beams so that they could be transported by the crane in July and August 2003 (Fig. 19). The five sandstone stelae were placed erectly in the laboratory along the sides of the walls in a proper way, so that they can be treated and restored (Fig. 20a). For details, see Chapter II, 3, Sandstone Stelae and Sculpture Project.

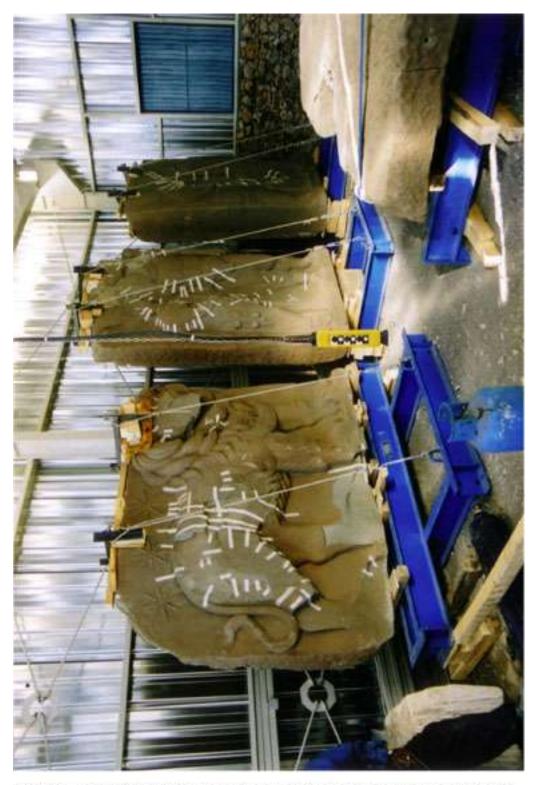
Fig. 20a. The sandstone dexiosis stelae and lion horoscope from the West Terrace placed in the temporary conservation and restoration laboratory.

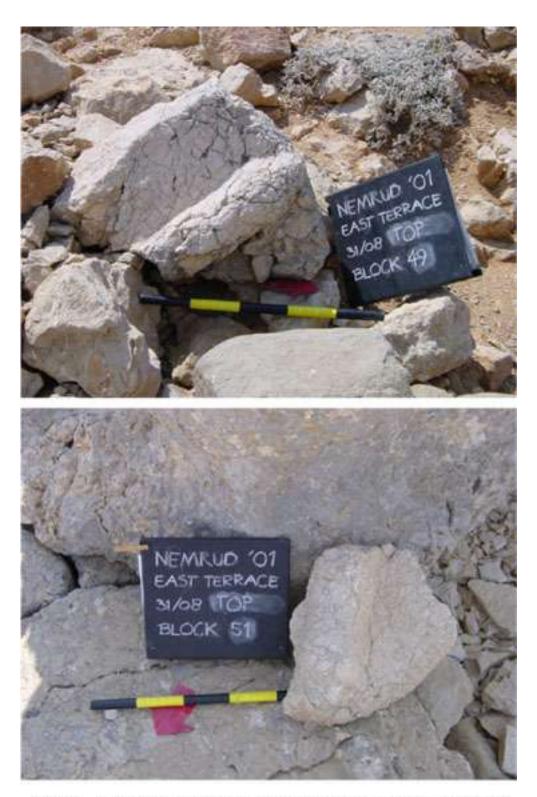
Fig. 21a-b. The two loose, broken off pieces of the left and right claws of the eagle (H), L 49 (left) and L 51 (right).

- The two loose, broken off pieces of the left and right claws of the eagle, L 49 and L 51 (see Fig. 21a-b, Pl. 19) will be placed properly in their original location and fixed with epoxy to block L 199. Optionally both blocks will be connected through one dowel pin to the joining claw sections of large block L 119. The dowel pins are made of stainless steel (*SS steel Remanit 4541*); the length is 200 mm and the diameter 12 mm. The two pairs of holes, with a length of 10 cm, will be drilled by using an advanced, vibration-free diamand drill.
