III. STRUCTURAL STABILITY AND EARTHQUAKE VULNERABILITY

Location of Nemrut Dag with Emphasis on Seismic Issues

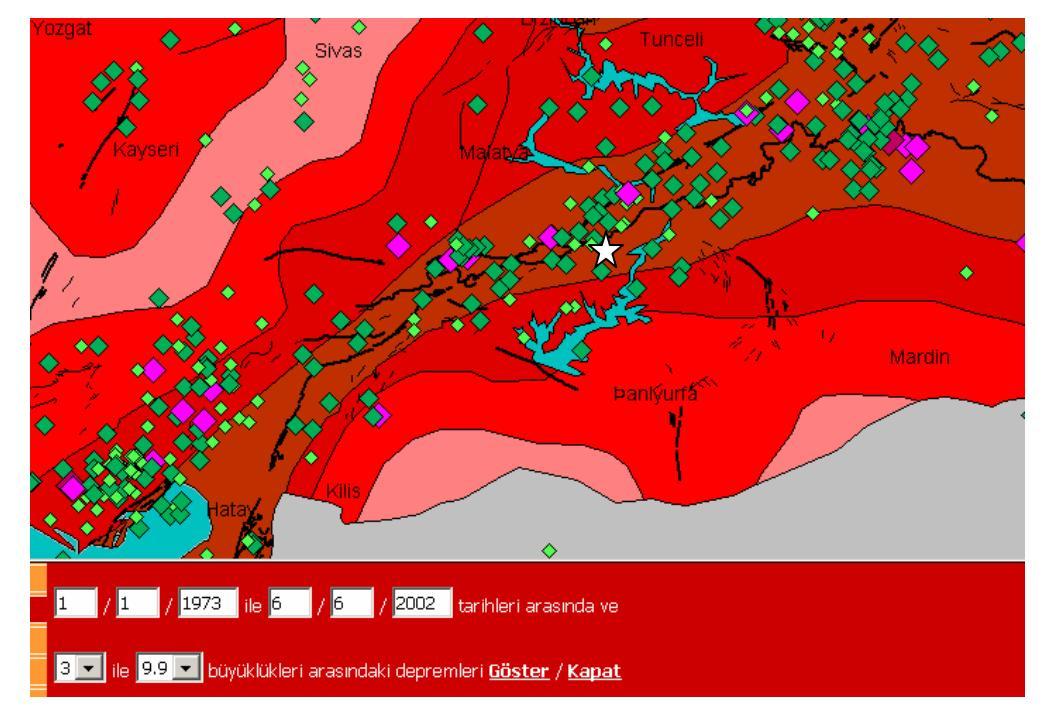
The activities recorded on the East Anatolian Fault can be seen using the *earthquake location* and magnitudes map from USGS database for 3.0 to 9.9 and 4.0 to 6.9 ranges in Figure 5 and

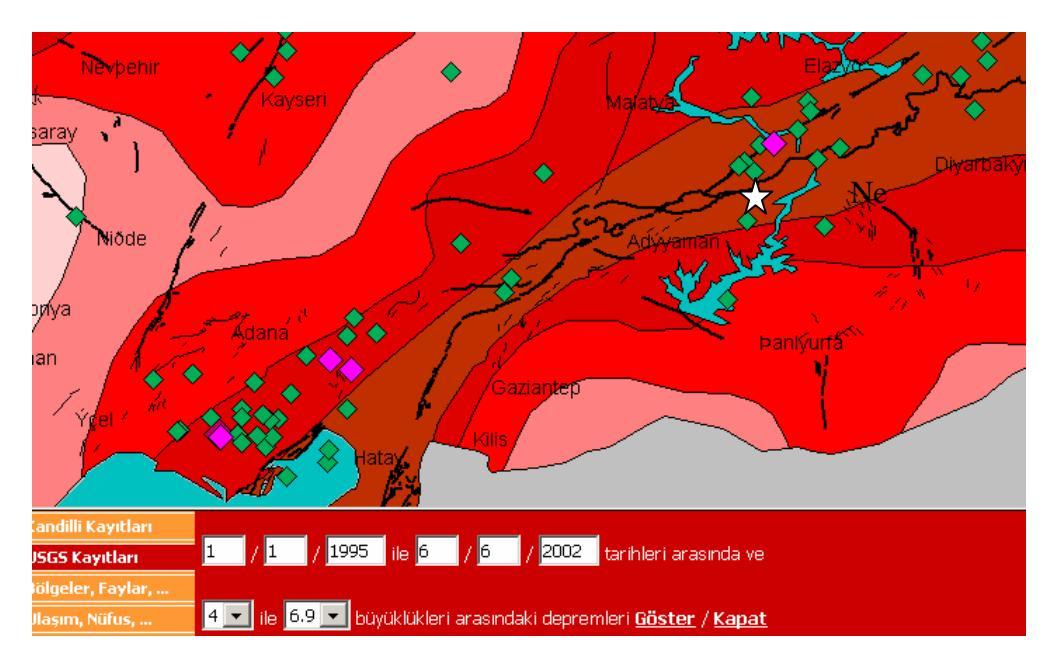
Figure 6 Earthquakes in the Region Since 1973 for Magnitudes Between 4.0 and 6.9

Figure 6, respectively. The Nemrut Site is marked with a 'star' in both figures. As clearly seen from these figures, the faults are seismically active and capable of generating large earthquakes.

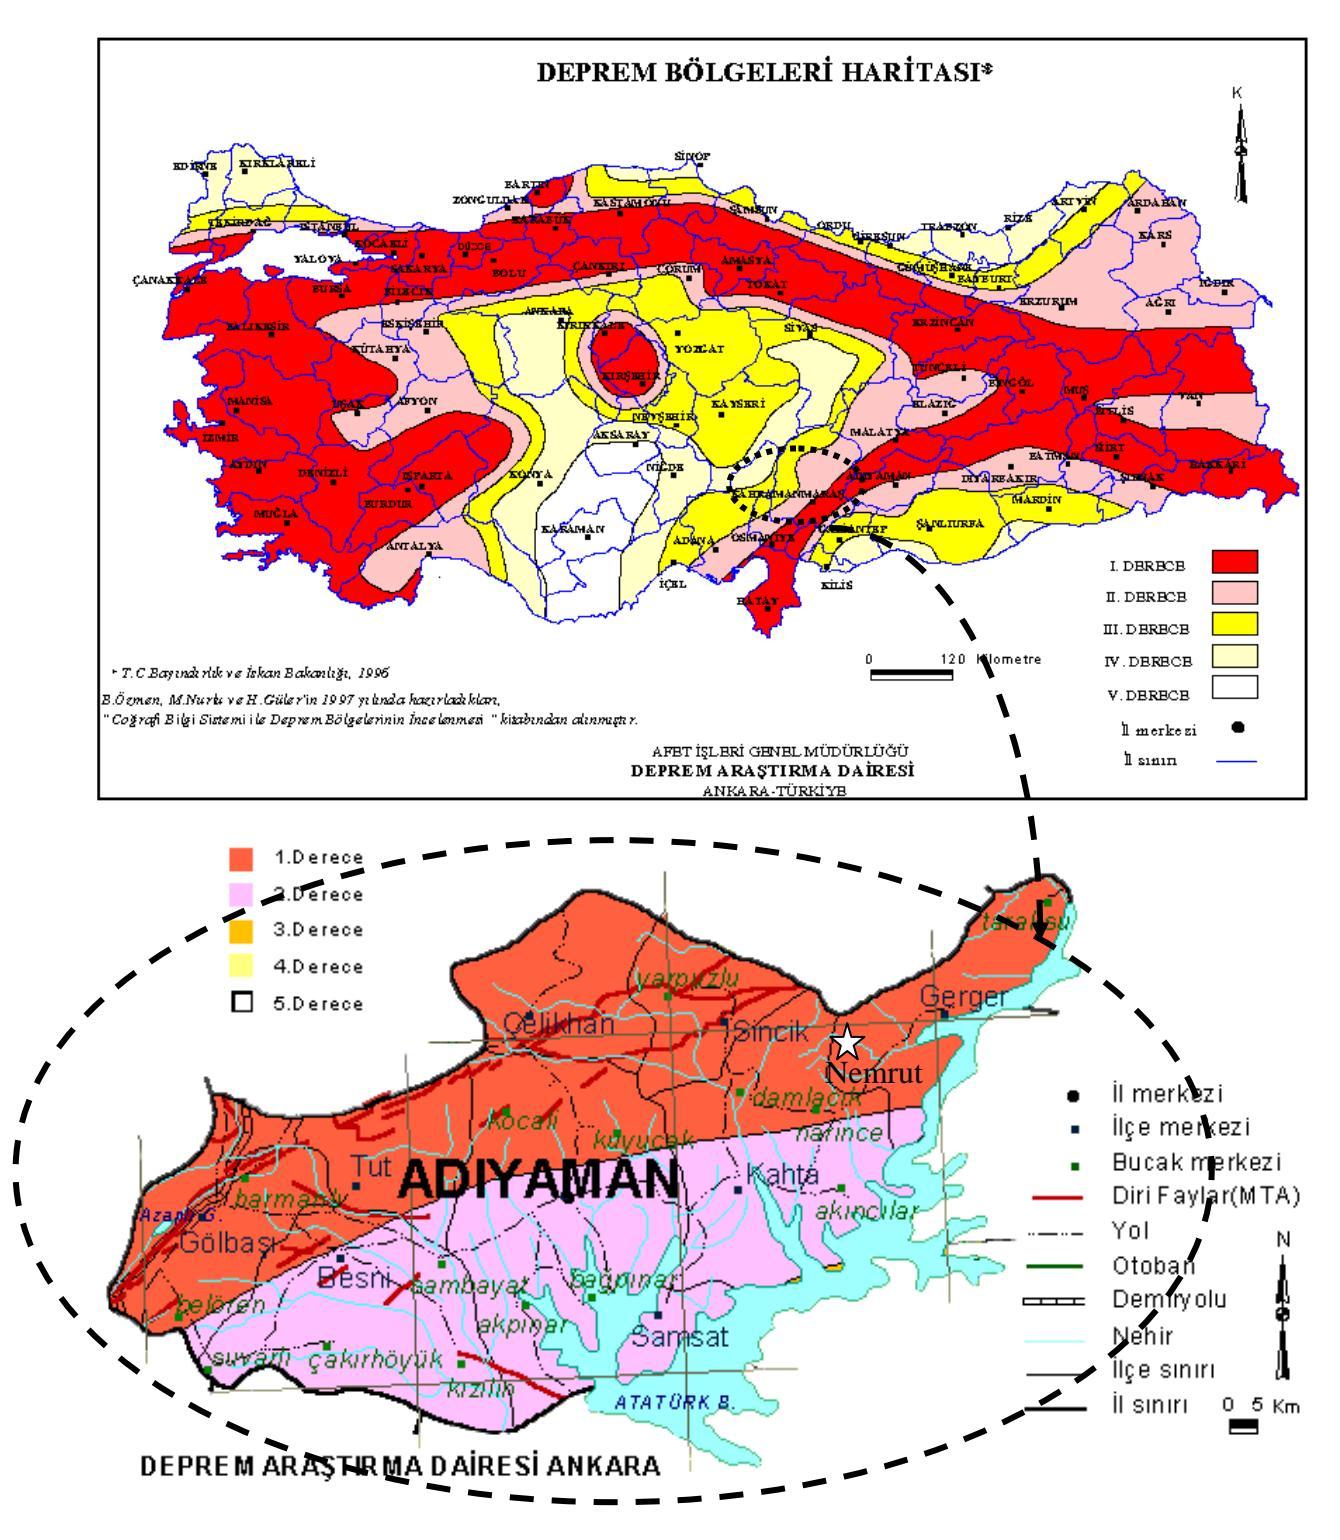
Figure 7 Adiyaman Earthquake Zone Map

Both of the maps shown in the above figures overlapped with the *Earthquake Zoning Map of Turkey*. It is clearly seen that the Nemrut site is located within 1^{st} degree earthquake zone. The earthquake zone map of Adiyaman (Figure 7) is also provided below for further examination.

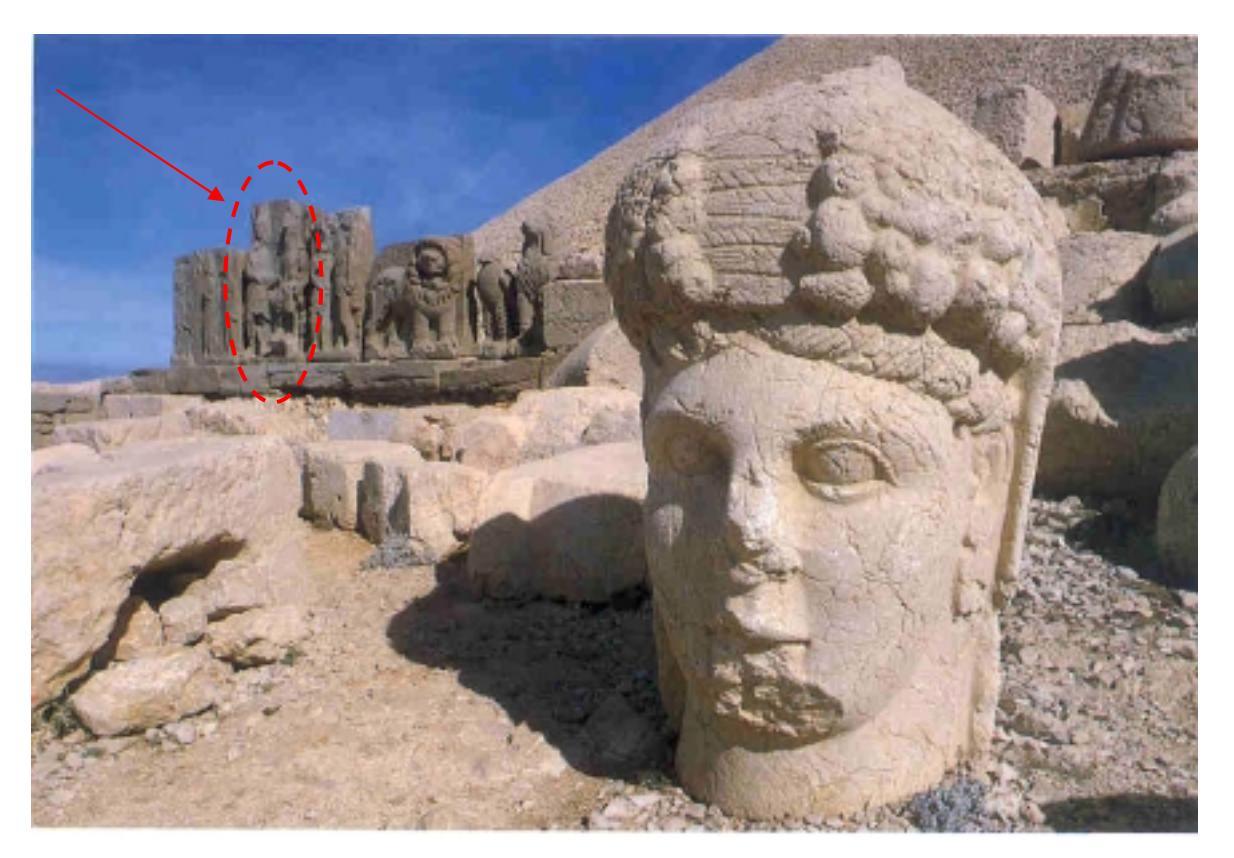
Figure 12 Stelae on West Side before Damage

- The second Stelae from the left was tipped and fell face wards during snowy season (Figure 11). (Before damage condition can be seen from the local postcards Figure 12). The current condition of the stone is very unstable and in a dangerous condition for itself and for the visitors. The Stelae must be urgently stabilized.
