### The Nemrud Dağ Project

Proposal for the 2004 campaign

# STRUCTURAL CONSOLIDATION OF NEMRUD SCULPTURES

**Mission Report, 2003**

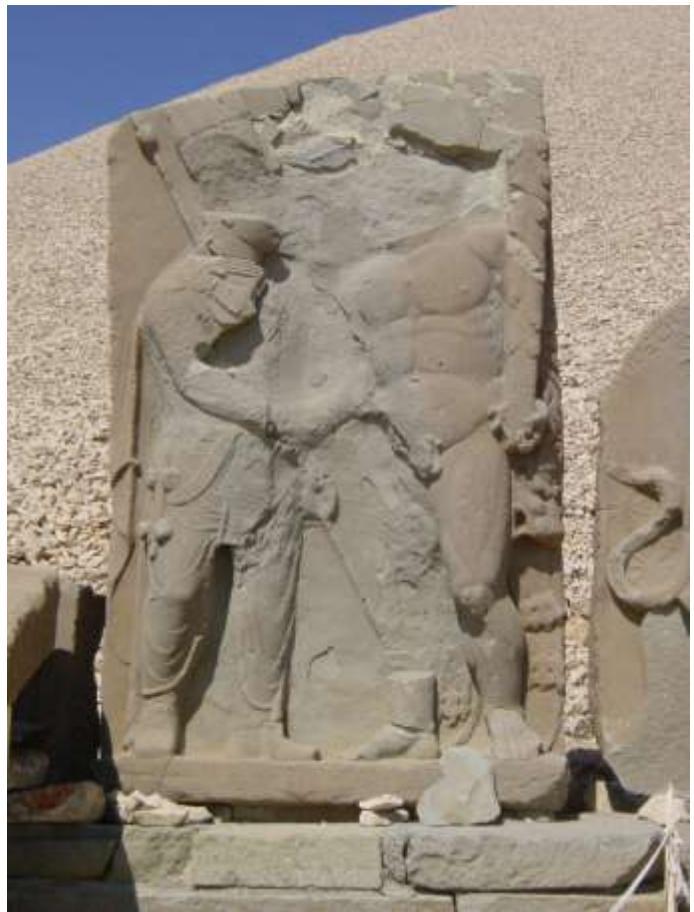
Herakles-dexiosis relief as preserved in 2001

During the 2003 campaign the four *dexiosis* reliefs and Lion Horoscope were protected by bringing them to the restoration house. It is our intention to restore and conservate them, where possible, during the next campaigns. There are many fragments of the *dexiosis* reliefs and ancestor stelae very well preserved in the storerooms of the Museum of Adıyaman. During the 2002 and 2003 campaigns an inventory and documentation was made of this material (see below). This dbase has to completed during the 2004 campaign. Then, there will thus be a dbase showing which fragments there are for the restoration of the reliefs.

As it is clear that an in situ display of the vulnerable tuffit reliefs and other sculpted elements is very bad for their condition, we propose that, after their protection, conservation and restoration, they will be displayed in the (future) site museum. Replica's will be placed in situ.

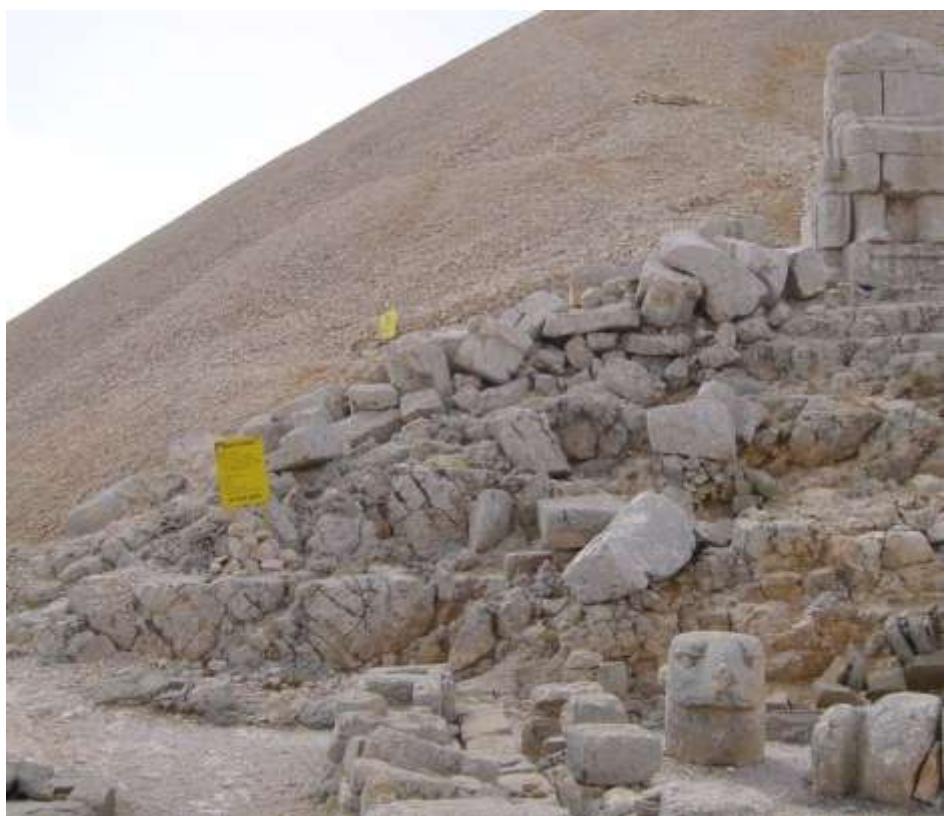
Blocks of statues A and B (lion and eagle)

Eight blocks have been identified as (probably) belonging to the statue: layer 2 is preserved in total (A2a, A2b and A2c); from layer 3 three blocks are still present (out of four) (A3a, A3b, A3c); from layer 4 one block (A4a) is present (out of two), as from layer 5 (A5a); the head has so far not been identified.

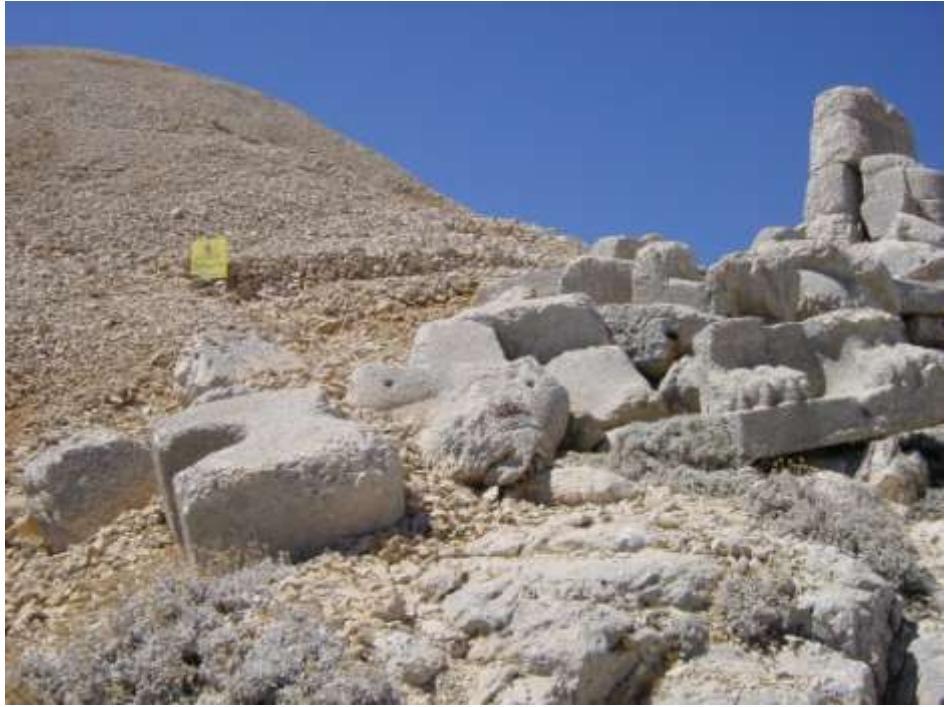
• Situation: remains of the statue are lying beside the original location towards the south side on the steep slope. The blocks are only partly visible due to gravel that has fallen down from the tumulus.

Remains of statue A (lion)

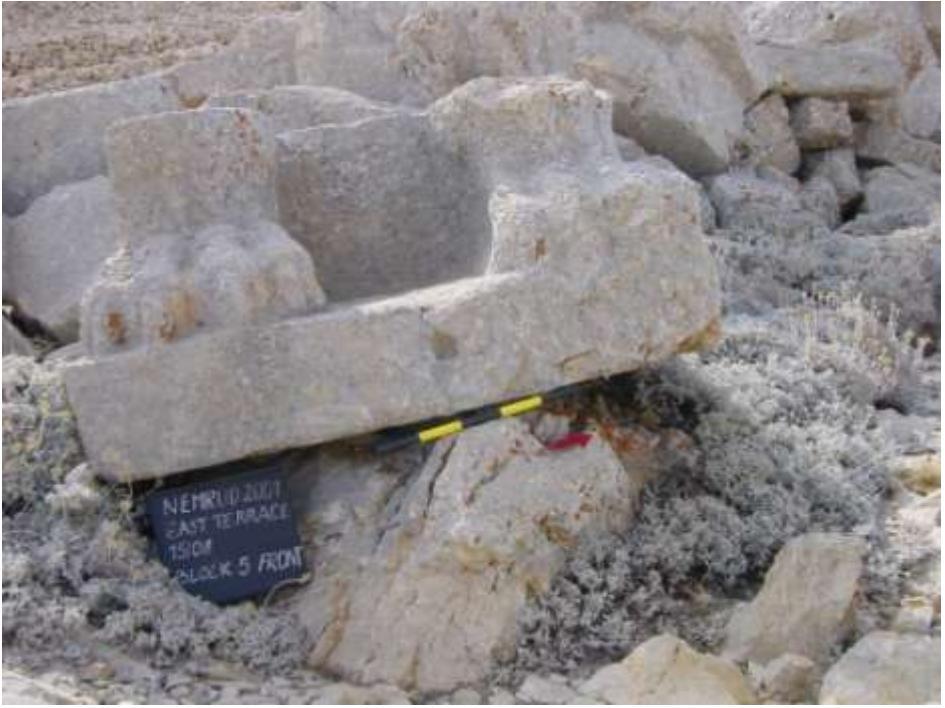
Block 5: A2a (lion)

- Restoration: repair and strengthening of broken blocks. Some blocks clearly show damages.

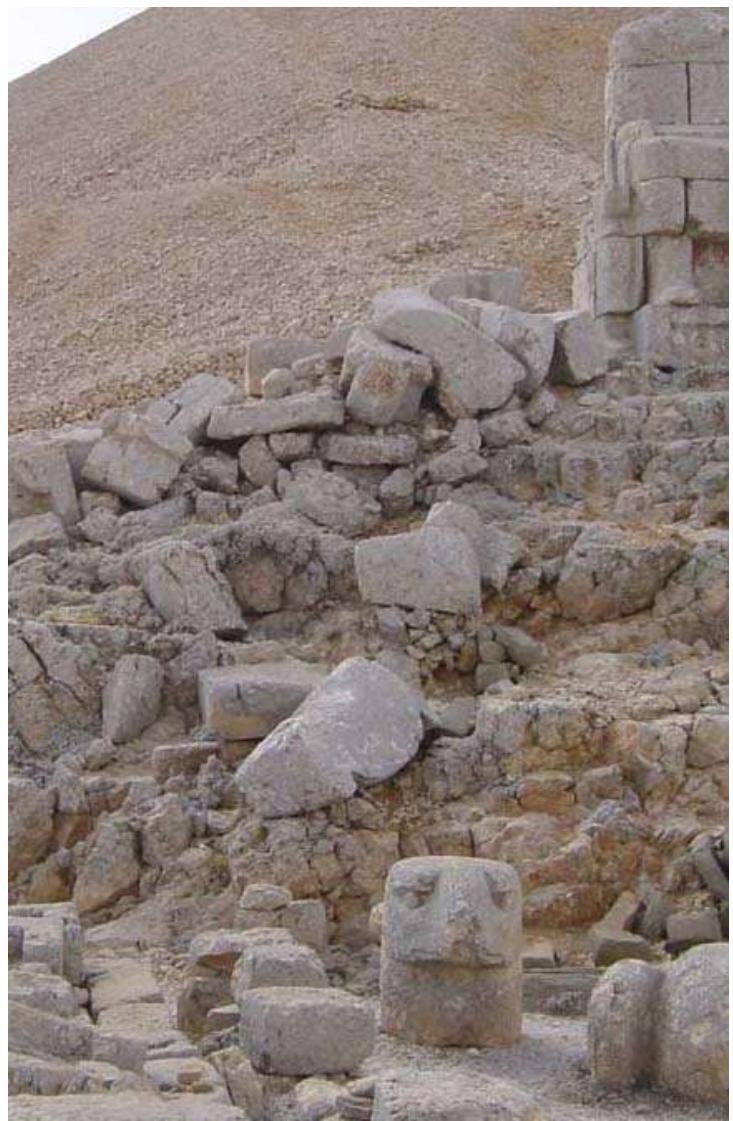
• Situation: remains of statue are lying in front of original location and on steep slope to south-east side. Nine blocks have been identified as belonging to statue. In all probability identified: all elements apart from block B4b.

Blocks and head of statue B (eagle)

- Proposed intervention
- Removal of all blocks and temporarily storage on East Terrace.
- Removal of gravel.
- Subsequent documentation and identification of single blocks.
- Stabilization of bedrock; restoration and reconstruction of base.
- Reconstruction of statue. There are some uncertainties as to our identification of

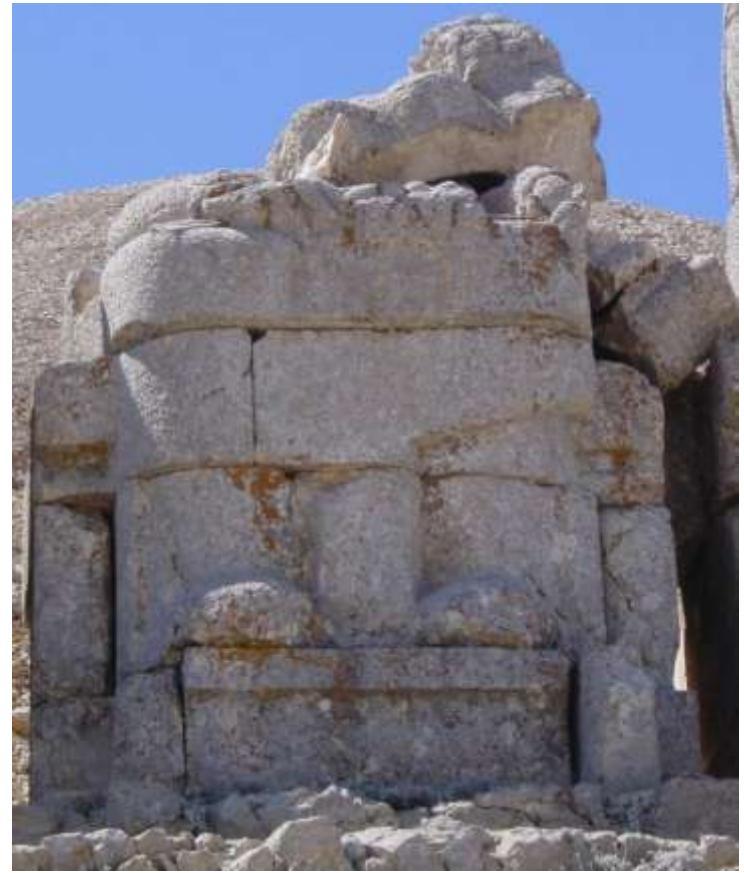
- Situation: statue is largely intact up till layer 4: these parts are well preserved. Breast piece (originally two pieces (D6a and D6b), now three because one has been broken), head and *kalathos* are on East Terrace. Blocks from layer 5 have been transported to terrace in front. Structure and base have to be stabilized as some of the blocks are twisted from their original position.
- Proposed intervention:
- Stabilization of base.
- In situ stabilization of the statue.
- Repiecing the broken elements.
- Head, deteriorated by algae, has to be treated/restored.

Statue D (Kommagene) as preserved in 2001 (present state differs; breast piece is now on the terrace)

We intend to glue the quickly deteriorating shoulder and breast pieces of statue D (Kommagene) to prevent further deterioration.

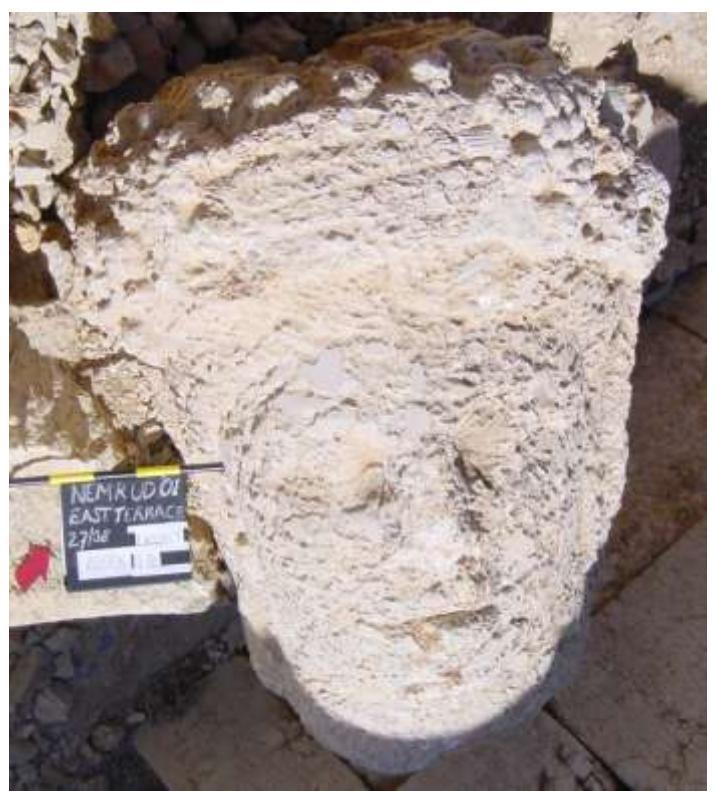
Head of statue D (Kommagene) (block no. 19) as preserved in 2001

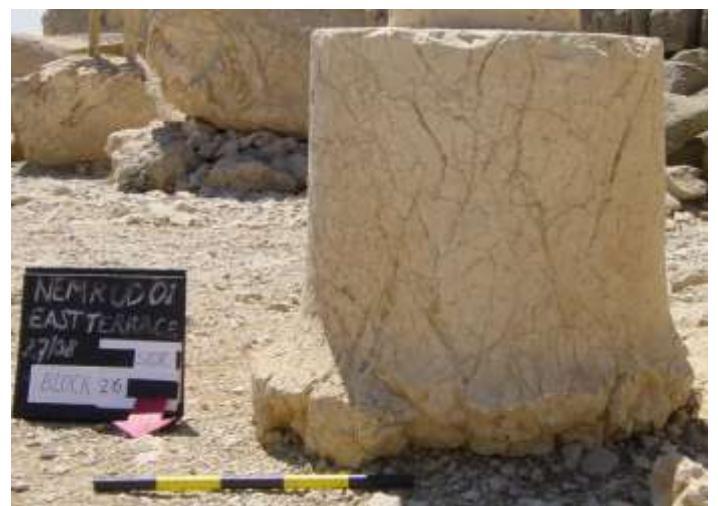
Kalathos of Kommagene (block no. 26) as preserved in 2001

The *kalathos* has to be restored by pasting and the use of small pins.

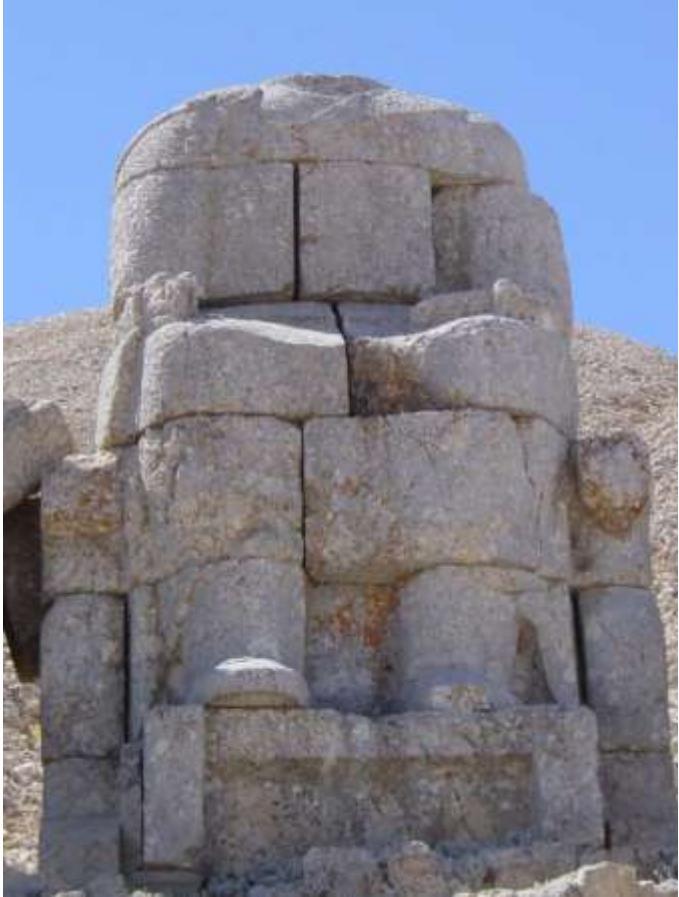
• Situation: statue is largely intact and standing upright; only head and *tiara* are on terrace. A stone in body part is visibly dislocated and vertically separated. This points to initial "general instability" that has resulted also in crushing of stone blocks in lower rows.

Statue E (Zeus) as preserved in 2001

- Proposed intervention :
- In-situ stabilisation.
- Subsequent documentation.
- Stabilization of base.

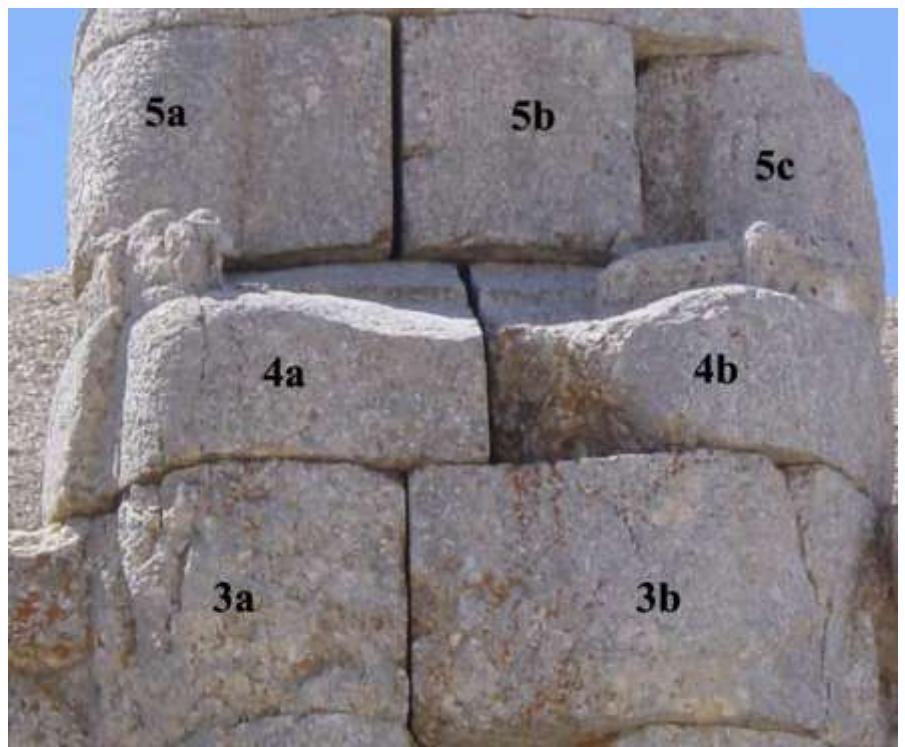
Statue E (Zeus): layers 3, 4 and 5

Block E3a (front) damaged at front side.

Block E3b (front) damaged at left lower side.

Block E3d (back) damaged at left lower side.

Block E4b (front) damaged at lower left side: a newly made piece of stone will be made and fixed.

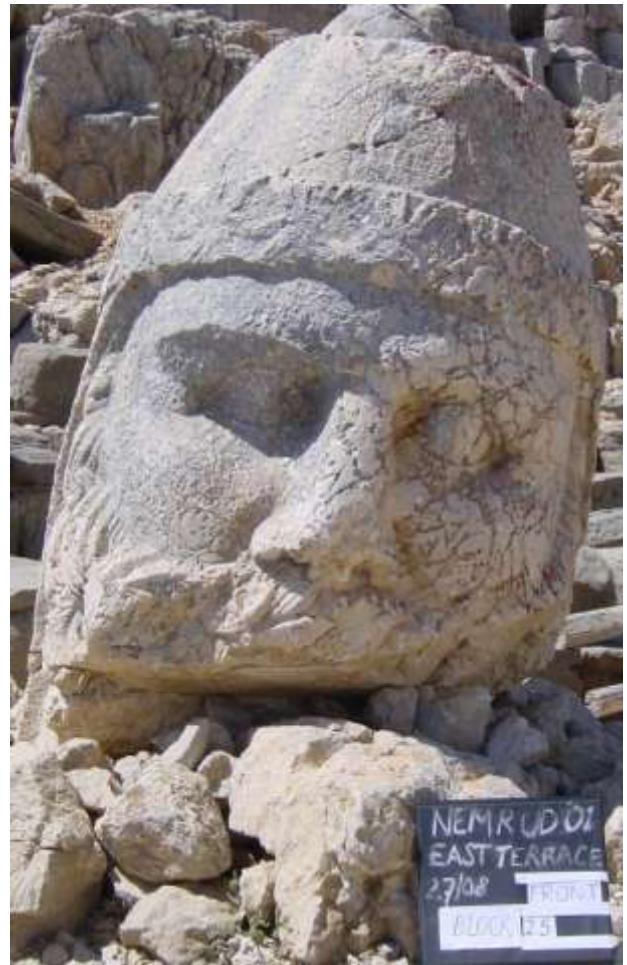
Head of statue E (Zeus) (block no. 25) as preserved in 2001

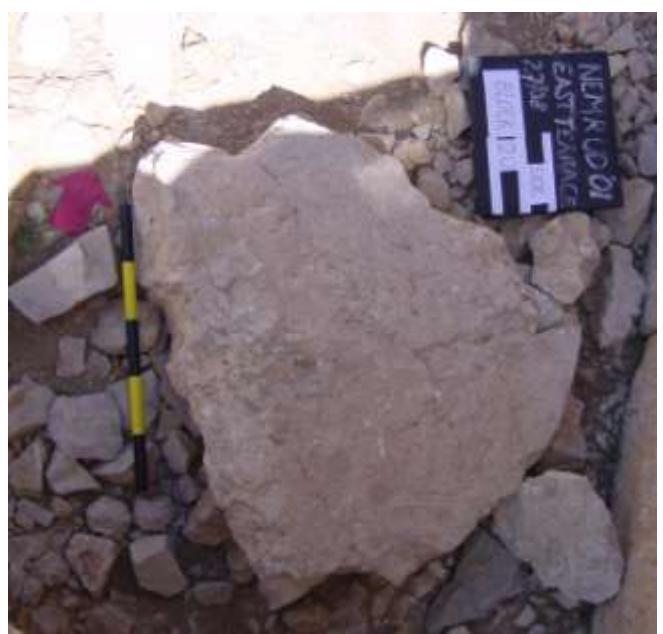
Part of tiara of statue E (Zeus) (block no. 20) as preserved in 2001

The tiara has to be restored (pasting newly made pieces) on two sides and has to be fixed onto head.

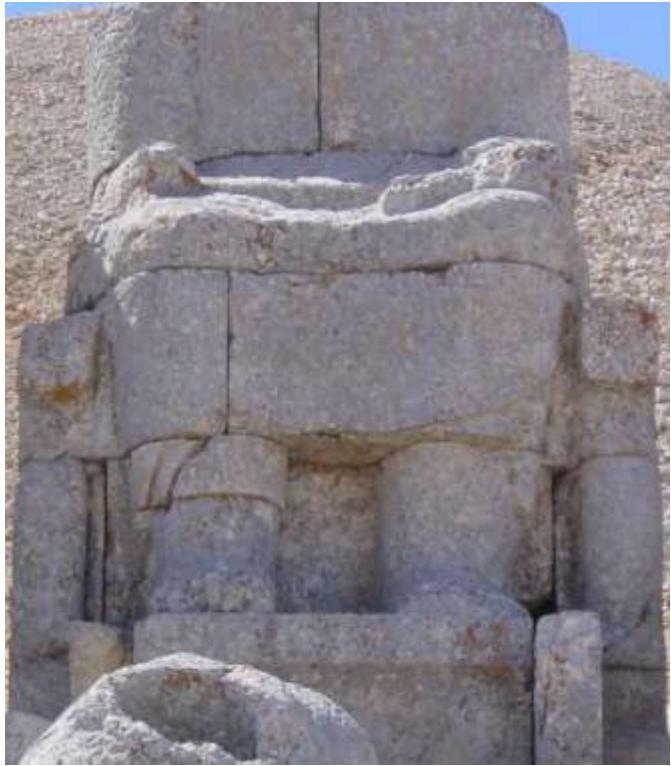
• Situation: statue is largely intact and standing upright; shoulder piece and head are standing on terrace. Instabilization of base has resulted in many vertical separation cracks; the statue is structural instable. Urgent measures for consolidation are necessary to avoid collapse.

Statue F (Apollo) as preserved in 2001

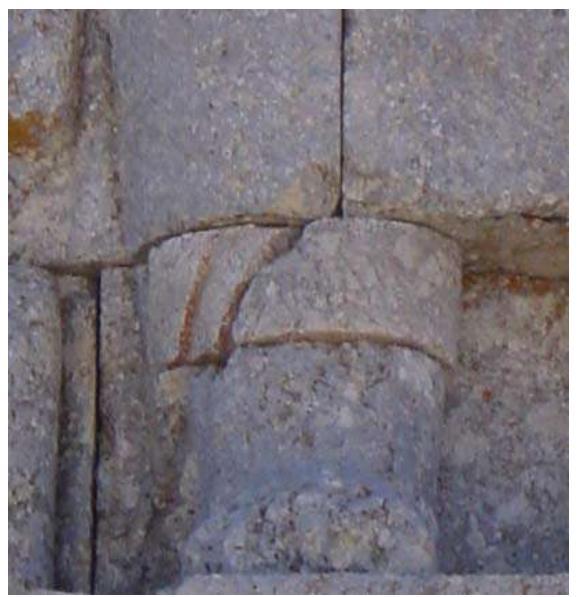
Block F2a (Apollo)

Block F2a shows an inserted element (antique restoration?); this block has to be fixed by pasting.

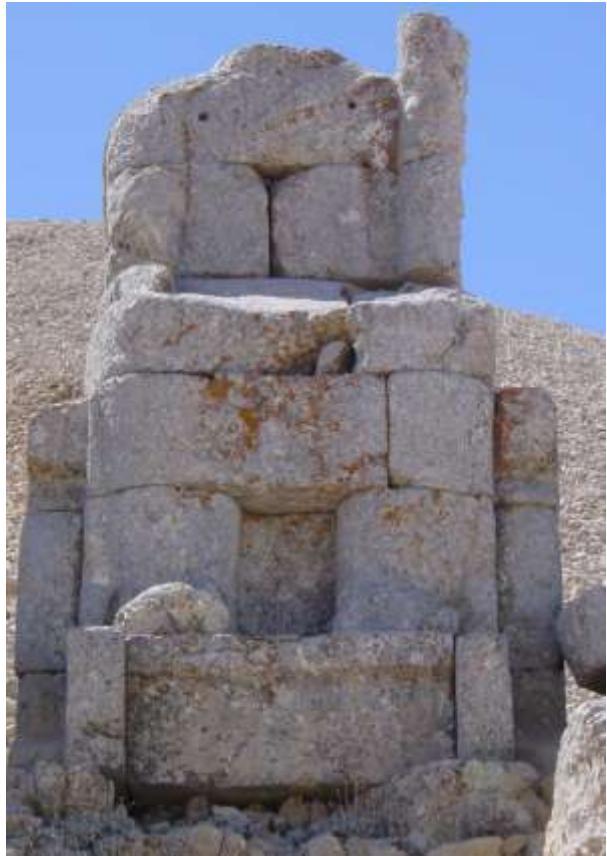
• Situation: statue is largely intact and standing upright apart from head; this stands on terrace. Three types of characteristic damage to statue have been observed: damages to principal structural system manifested by displacement of stone blocks from their original position leading to formation of gaps between blocks; damages to stones themselves particularly pronounced on front side and manifested by local failure or cracks and erosion; and

deterioration of bedrock/soil foundation, particularly expressed on front side. It is urgently necessary to intervene as stability of soil, i.e., bedrock, has suffered from considerable deterioration and erosion in course of time. Such an intervention is imposed by the need to prevent further erosion and make contact between principal structure and soil. The cavity caused on front side might induce failure of stone blocks leading to progressive failure of entire structure.

Statue G (Herakles) as preserved in 2001

- Stabilisation of base. It is recommended to perform permanent stabilization with improvement of existing soil by injection of rock mass and incorporation of new, stable and regularly shaped blocks below the existing blocks of statue. The contact between new blocks and existing ones (belonging to statue) should be dry, if possible, or should be made by use of hydraulic mortar or lead.

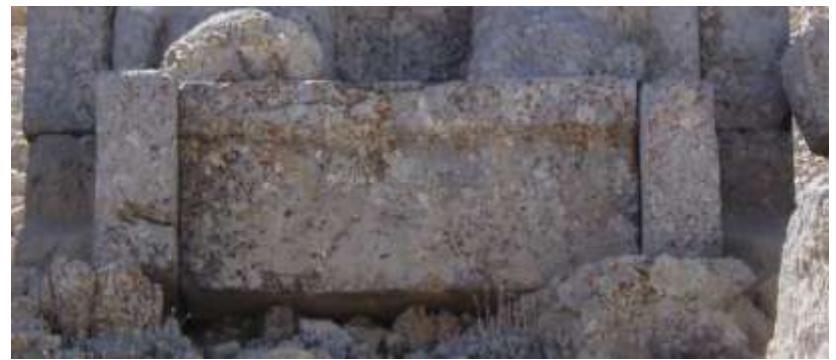
The temporary stabilization done during 2002 campaign involved cleaning of base, removal of tiny stones and failures and incorporation of stone blocks in form of walls and cramps. The new stone blocks basically transfer load from structure to base and prevent occurrence of cracks in lower stones and failure of statue. Stabilization of soil was not done. Dry stone masonry was used with the intention that this intervention be temporary and used material reversible.

Statue G (Herakles), base before temporarily stabilisation

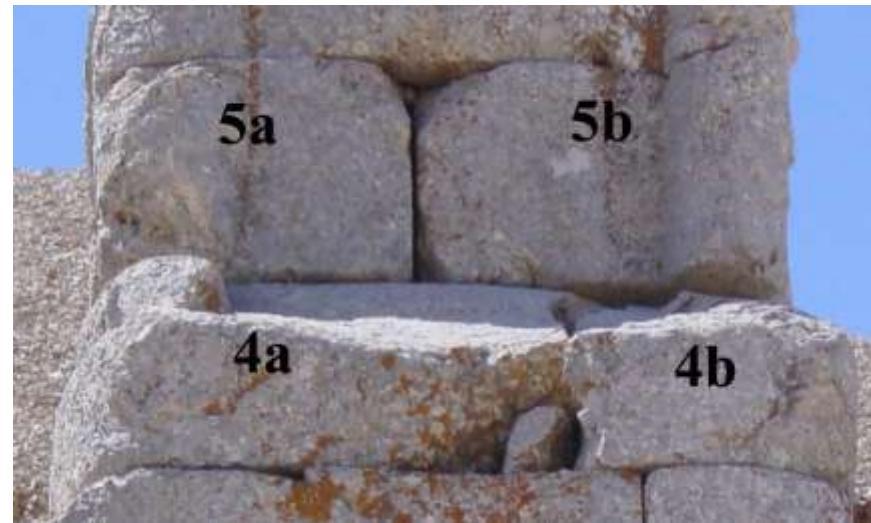
Statue G (Herakles), layers 4 and 5

Block G5a and G5b are damaged at front side on left and right sides: newly made piece of stone has to be inserted here.

Block G4a (lap) should be glued and pinned.

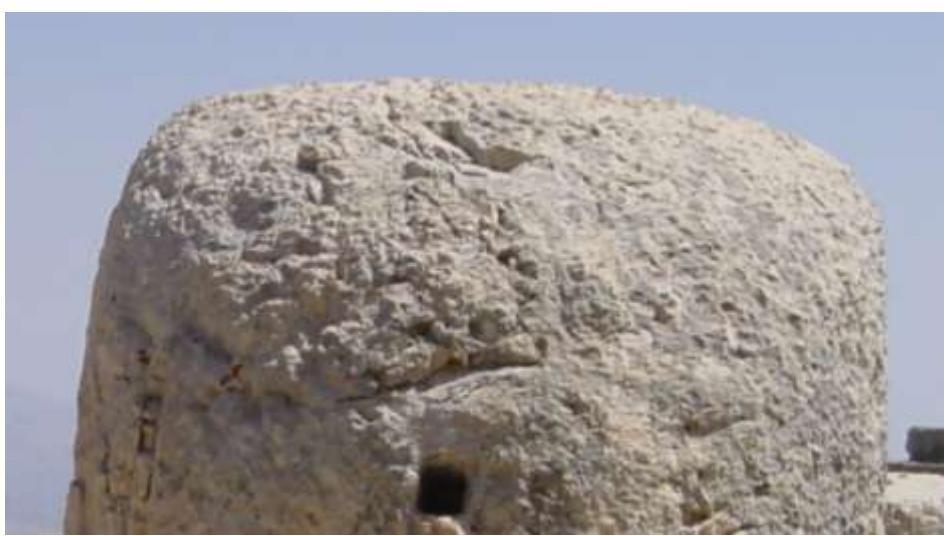
Detail crack block no. 35 (eagle)

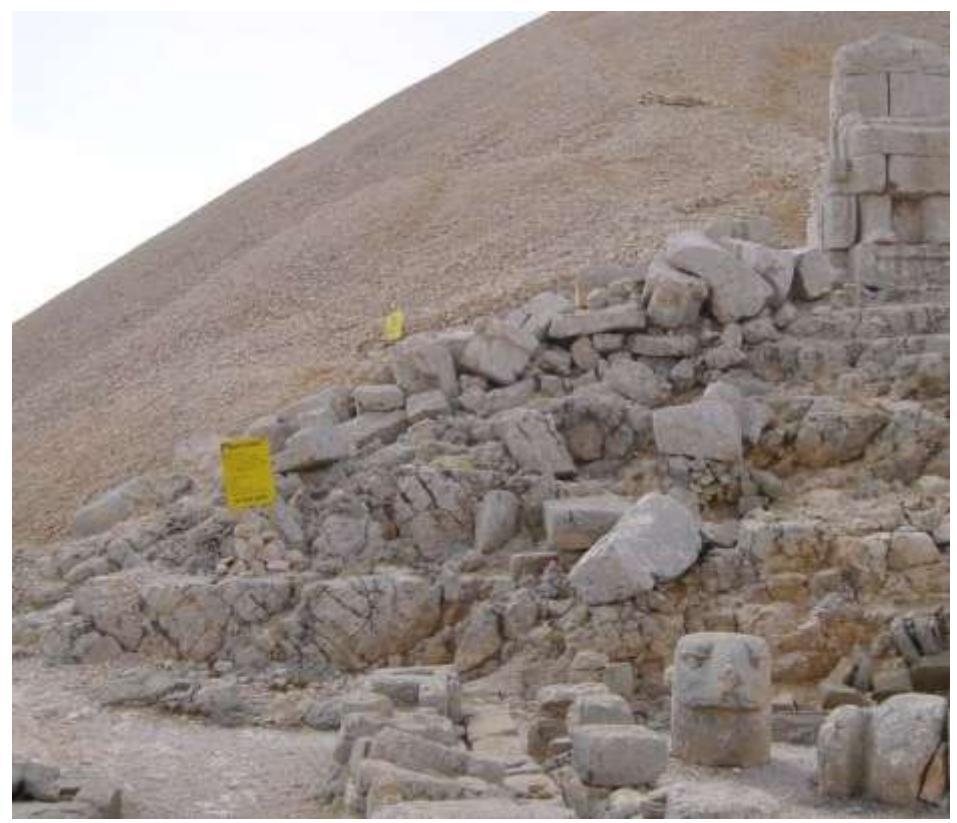
Given the present condition of the colossal statues on this part of the terrace it is impossible to prepare the restoration of statues A and B, since many blocks are buried under gravel that has come from the tumulus.

Present condition of the colossal limestone statues on the south side of the East Terrace

We therefore intend to dismantle the rubble of blocks at the south side of the East Terrace, hoist the blocks and to display them temporarily on the terrace. There they will be documented and studied for possible reconstruction during the 2005 campaign. During that campaign it will then be possible to stabilize the underground and base of the lion and eagle statue and to restore them.

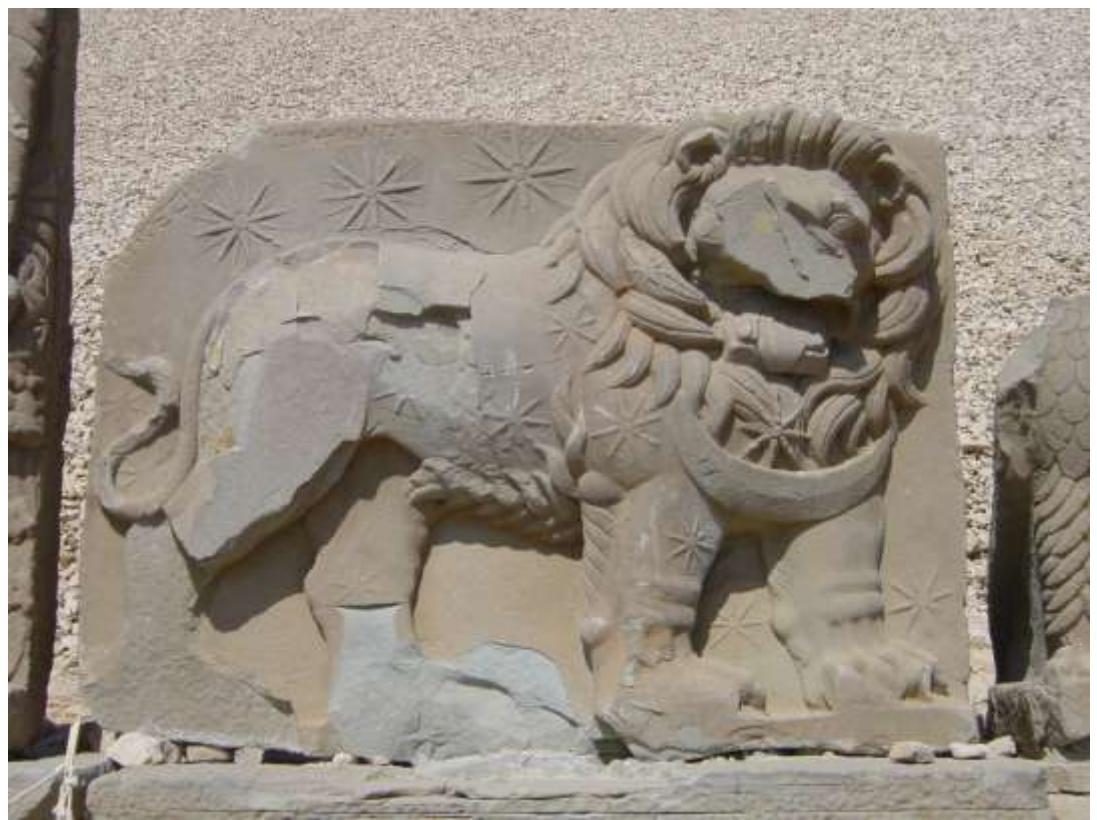
Lion Horoscope as preserved in 2001

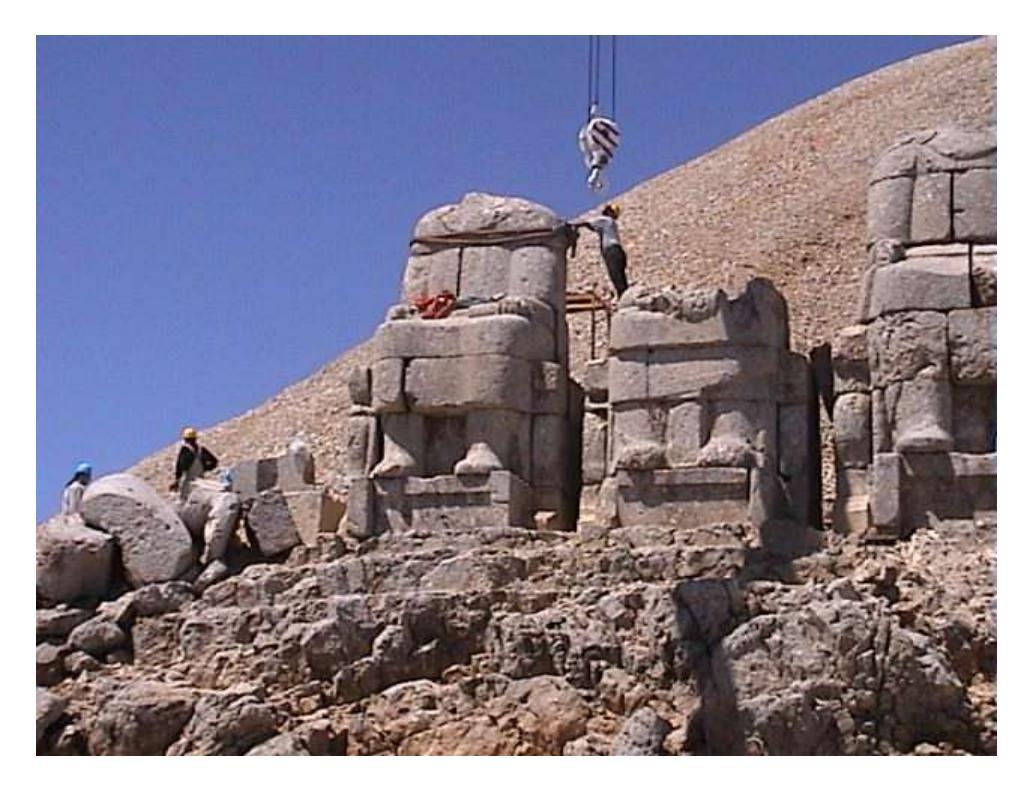
Photo 1. Antiochos statue - prior to intervention

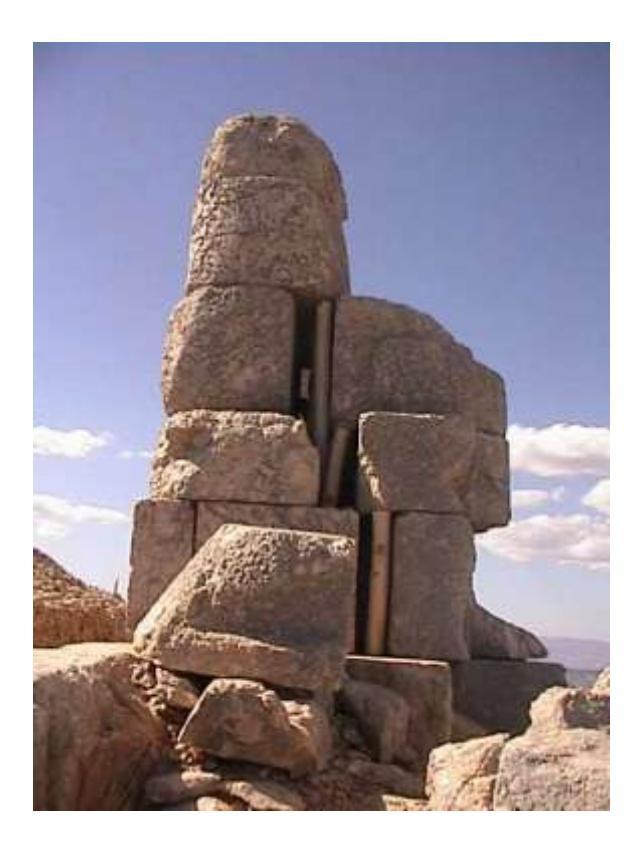
Photo 2. Antiochos statue - temporary support (2002)

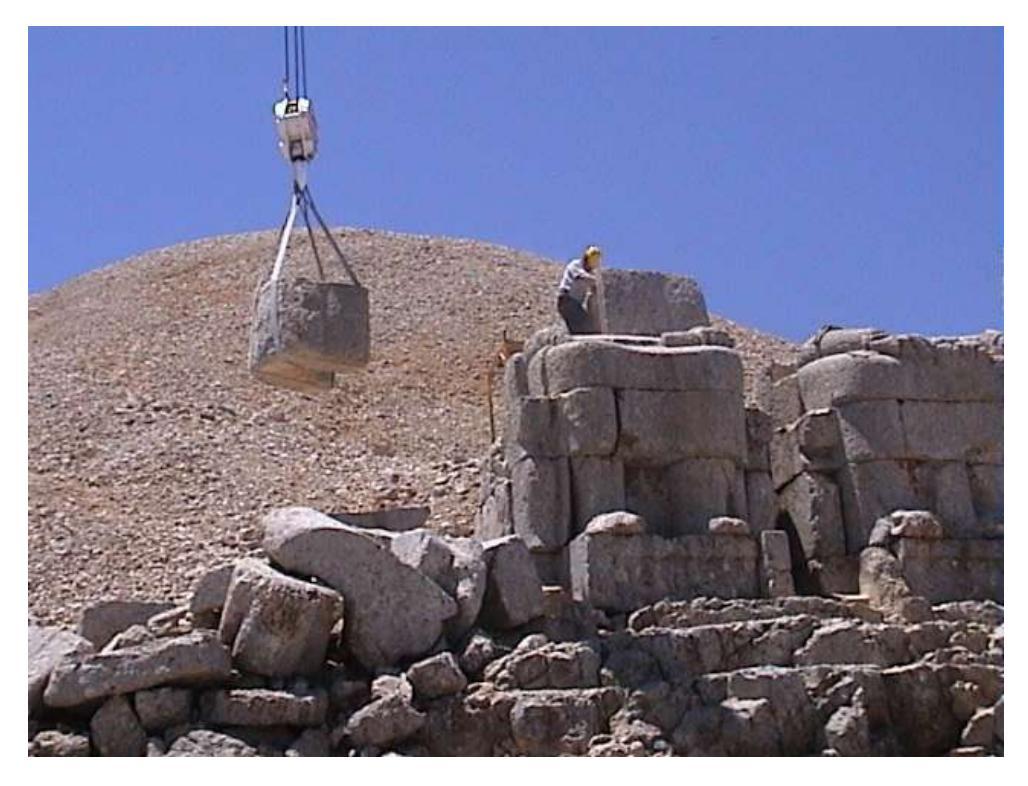
Photo 3. Antiochos statue – during reconstruction

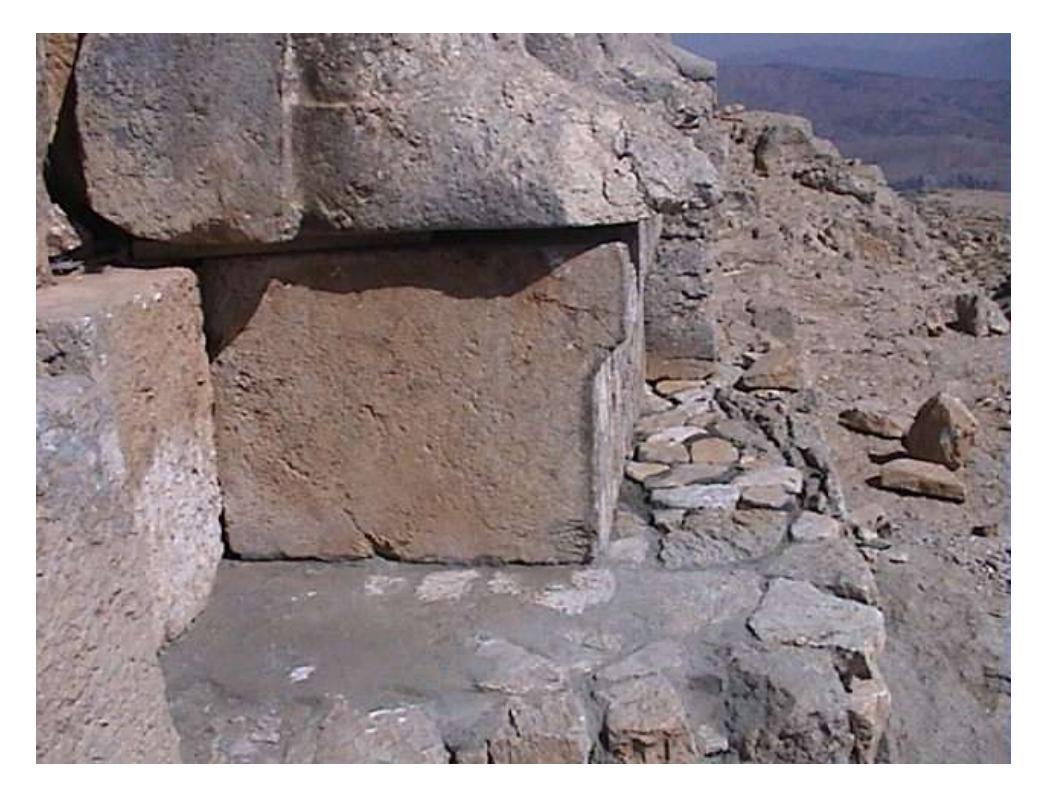
Photo 4. Antiochos statue – stabilization of ground layer

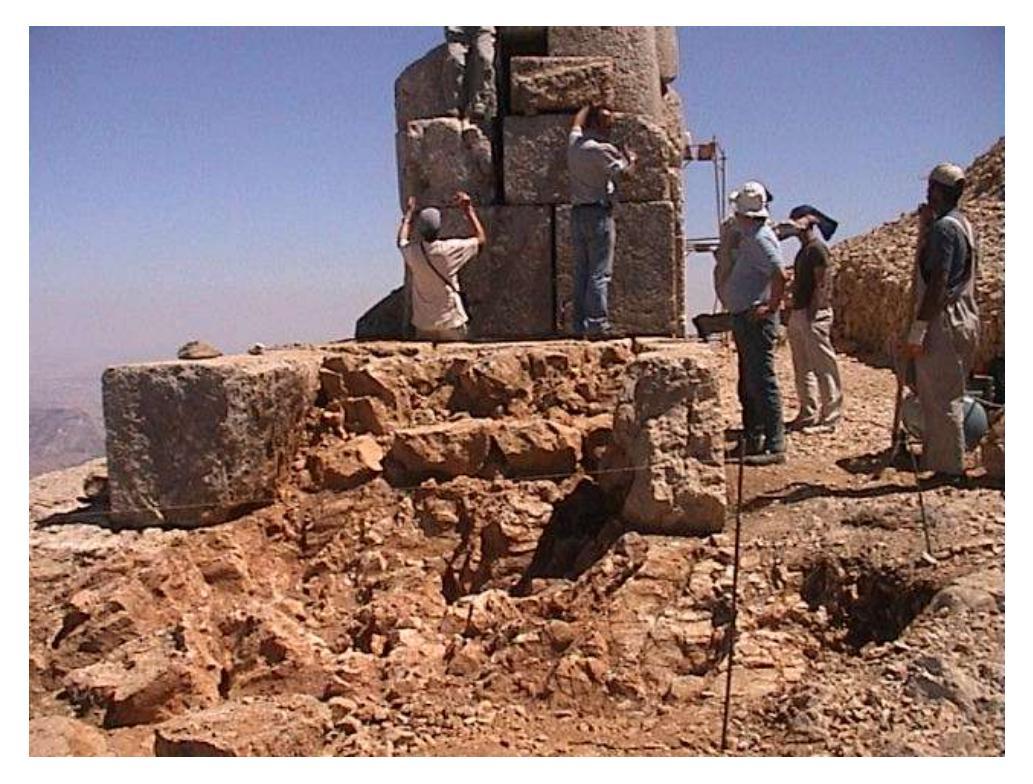
Photo 6. North Platform with Eagle and Lion statues - soil degradation

It is proposed to completely reconstruct the North Platform with the Eagle and the Lion statues and place the Eagle's head back to its original position. From the aspect of stability, a structural intervention involving stabilization and conservation of the Herakles statue is also imposed as necessary.

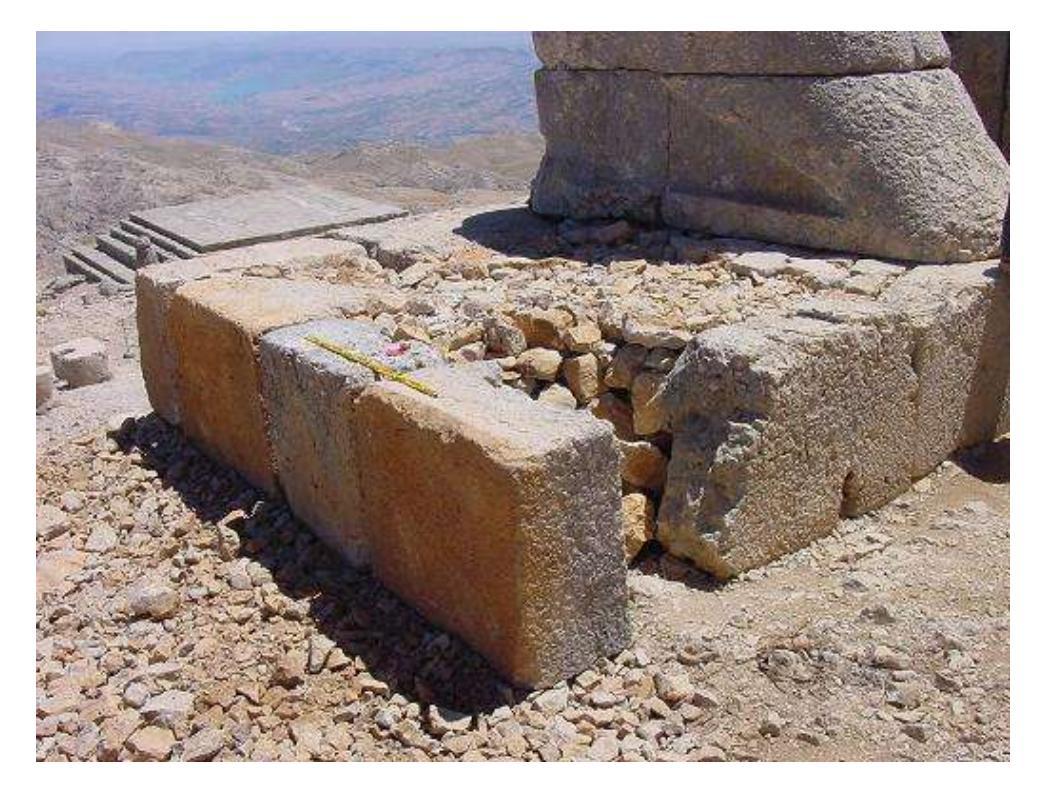
Photo 7. North Platform with eagle and Lion statues-reconstruction

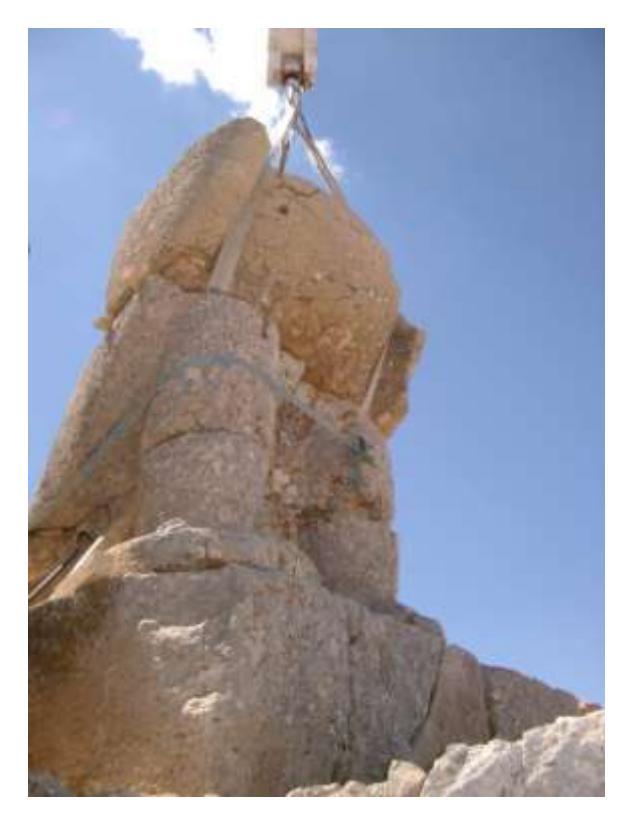
Photo 8 North Platform - proces of reconstruction of statue of Eagal

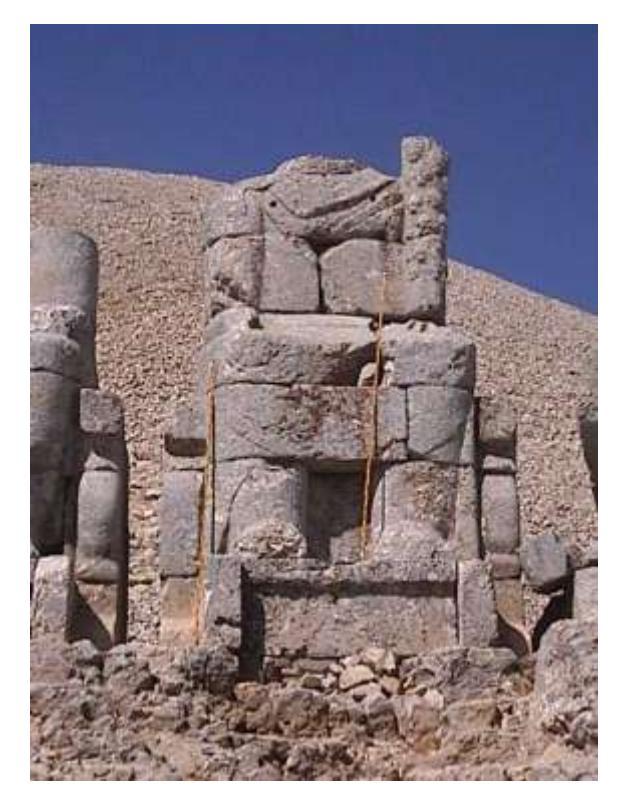
Photo 9. Herakles statue - present condition

Therefore the Herakles statue will be reconstructed in 2004 without the head. And further studies to put the head on top of the statue by dampers will be executed.
